# Roughness Characteristics of Natural Channels

By HARRY H. BARNES, JR.

U.S. GEOLOGICAL SURVEY WATER-SUPPLY PAPER 1849

*Color photographs and descriptive  
data for 50 stream channels for  
which roughness coefficients have  
been determined*

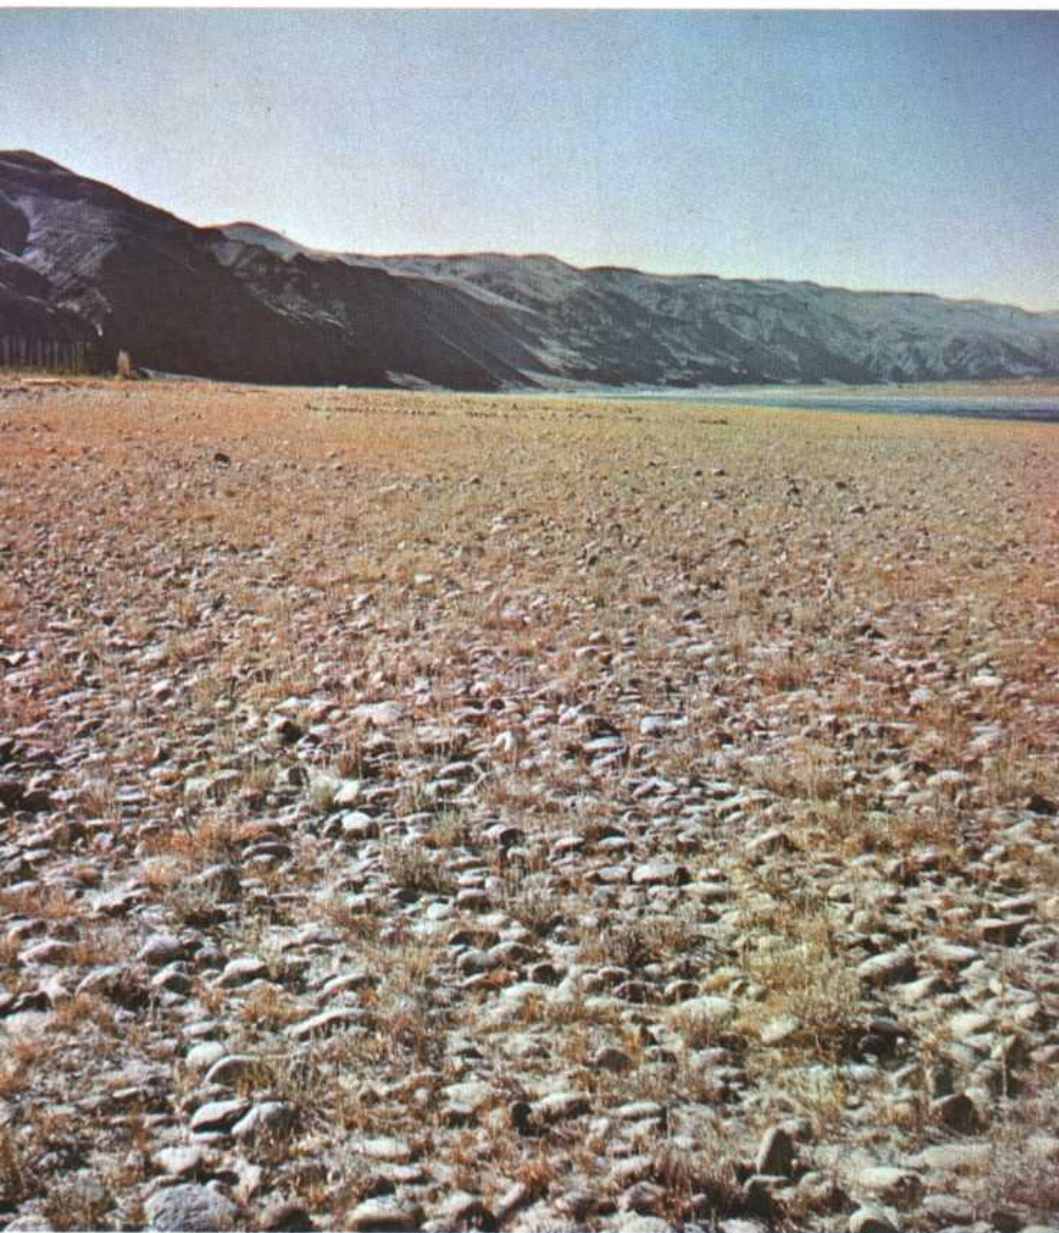
No. 67 upstream from top of bank at section 3,  
Columbia River at Vernita, Wash.

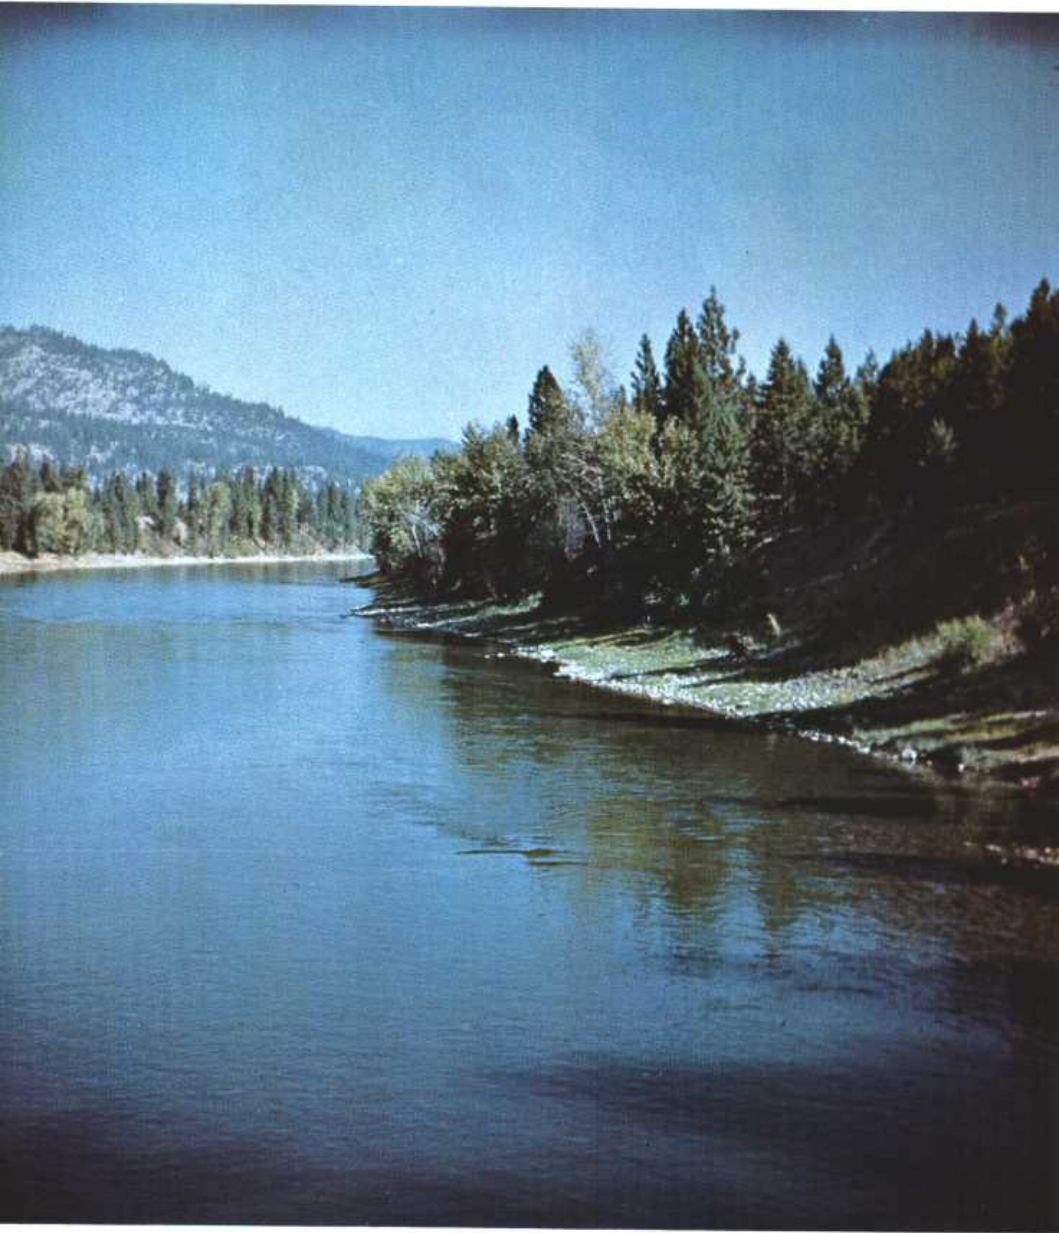
No. 22 downstream along right bank from section 2,  
Clark Fork at St. Regis, Mont.

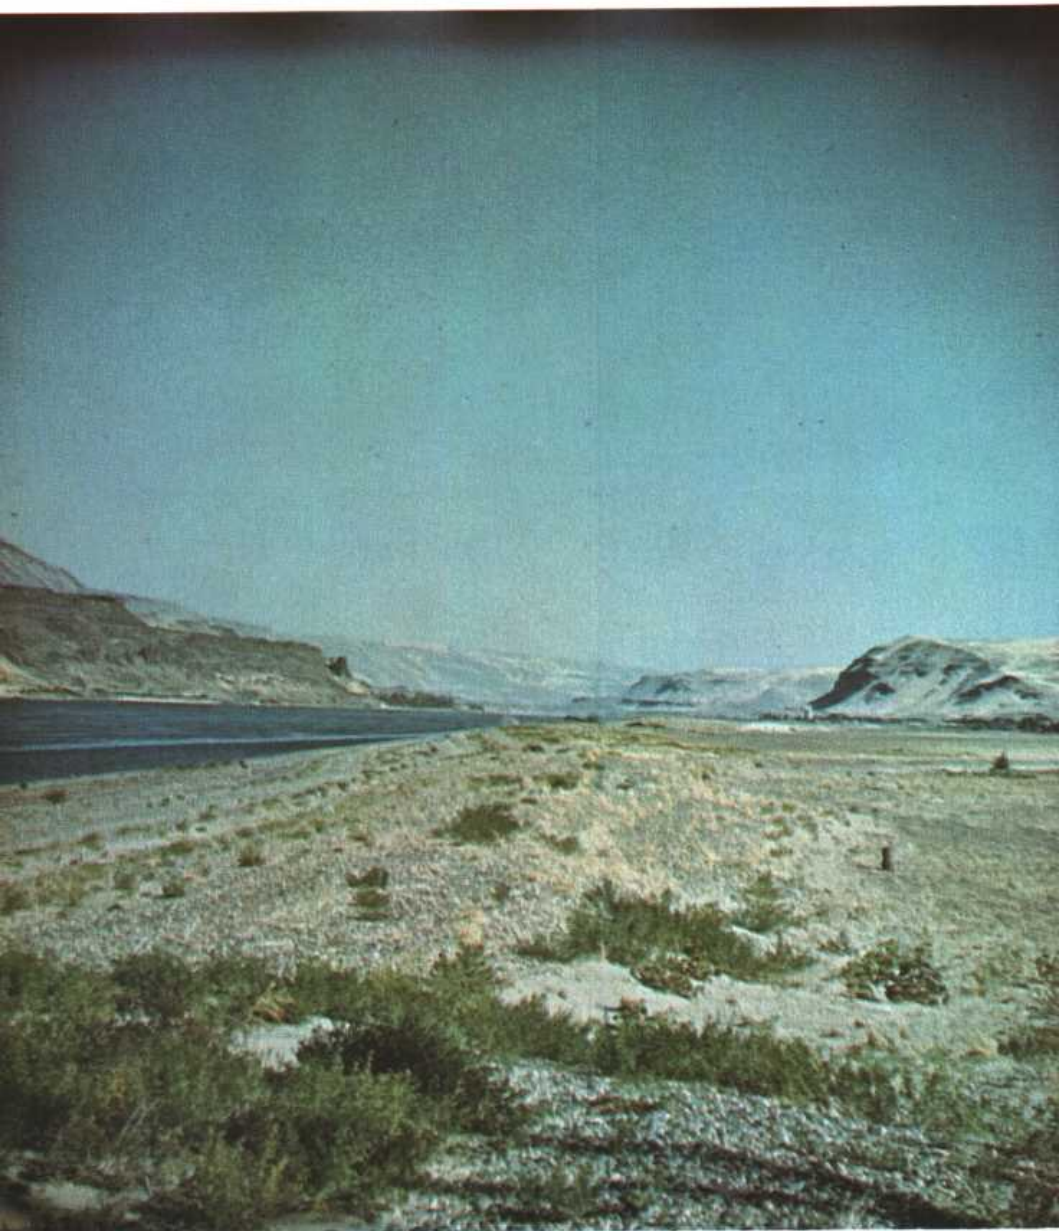
No. 38 upstream along left bank from section 4,  
Columbia River at The Dalles, Oreg.

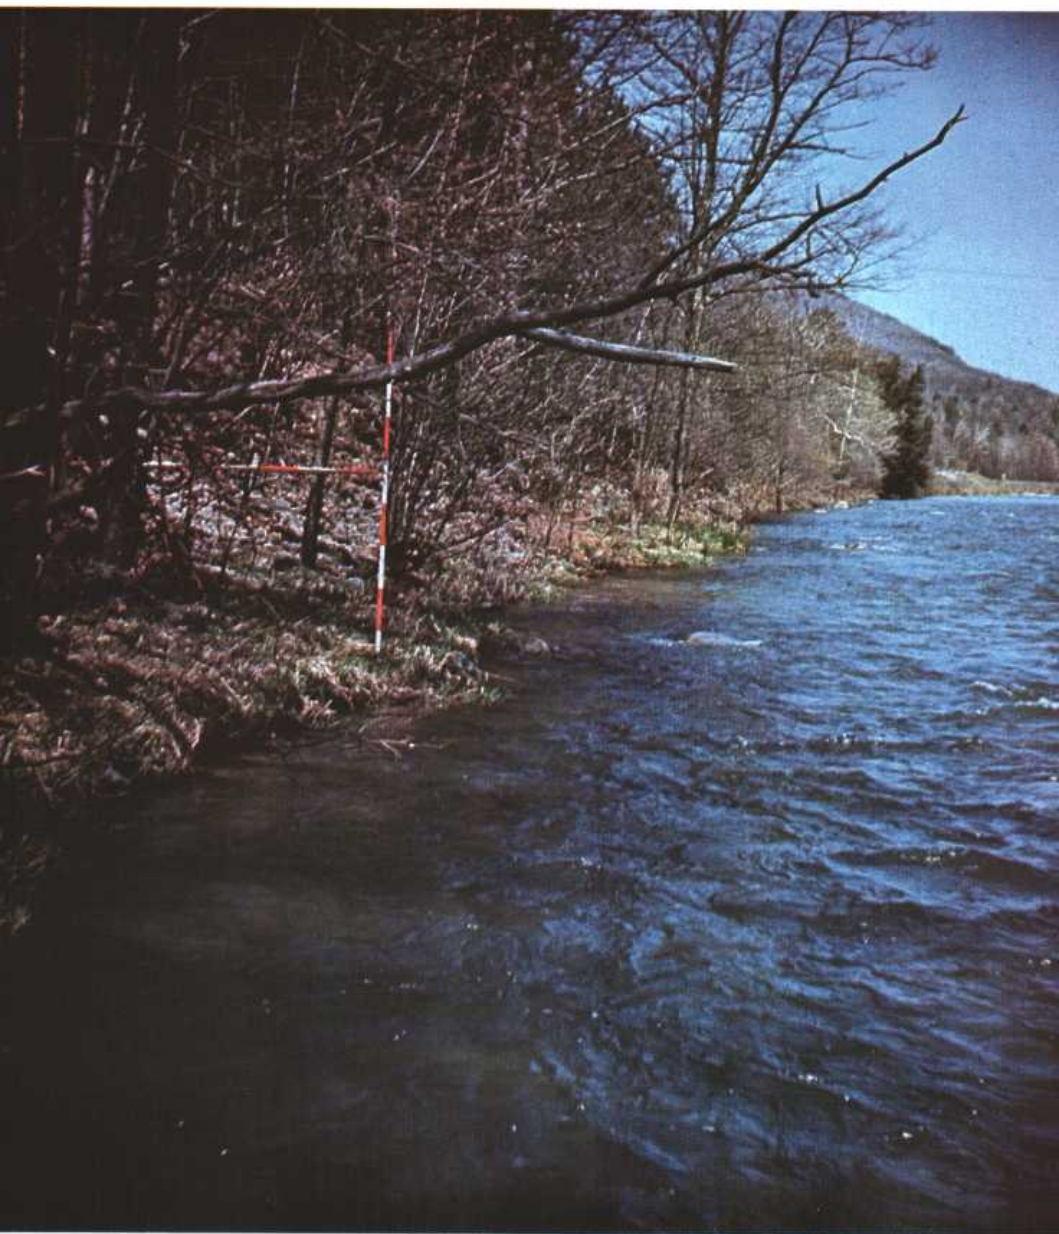
No. 354 upstream along left bank from section 2,  
Esopus Creek at Coldbrook, N.Y.

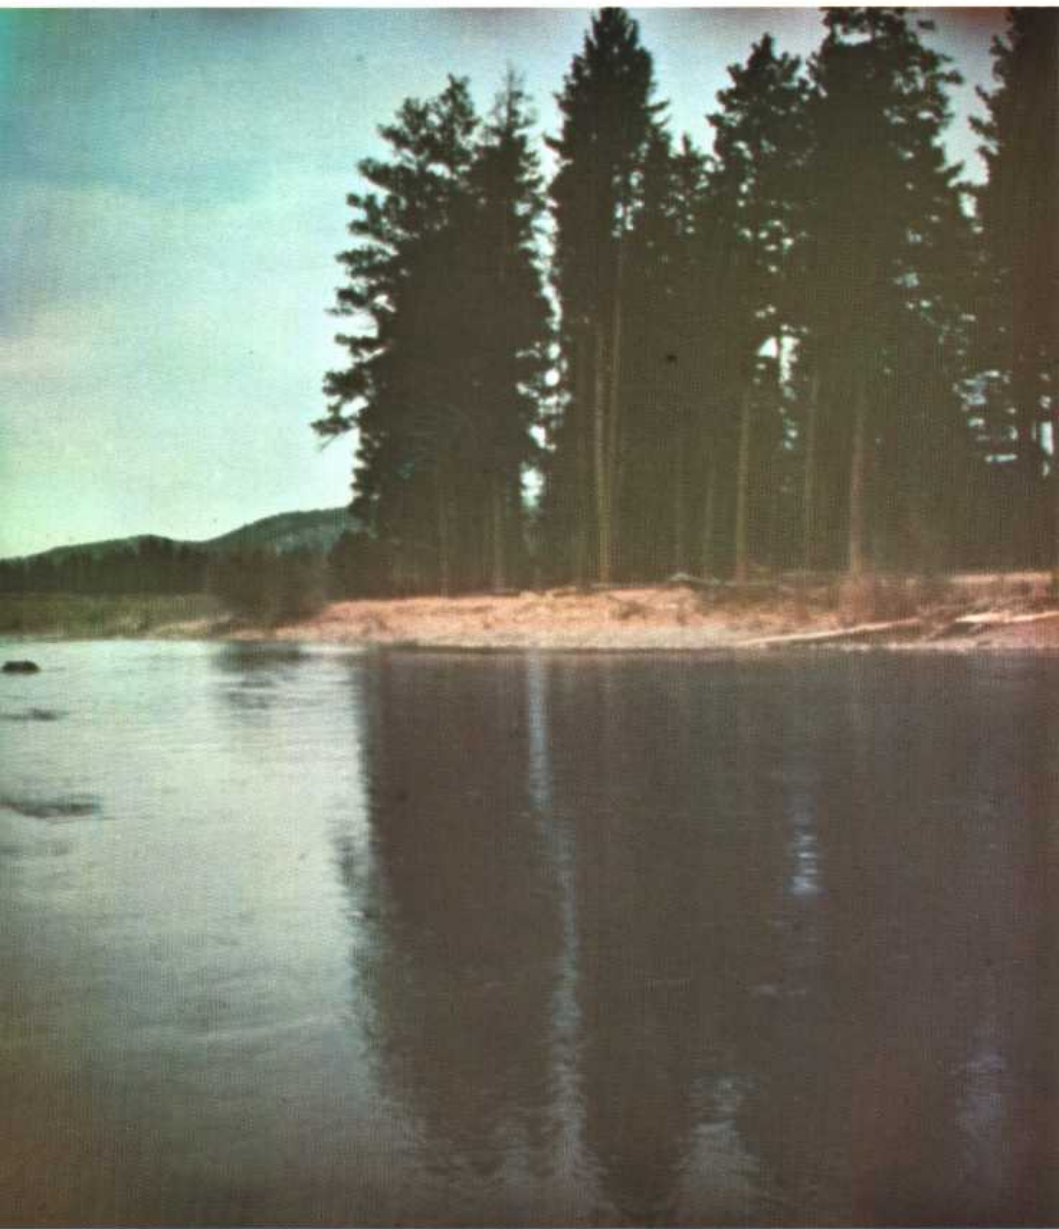
No. 1 downstream from left bank above section 1,  
Blackfoot River near Ovanda, Mont.

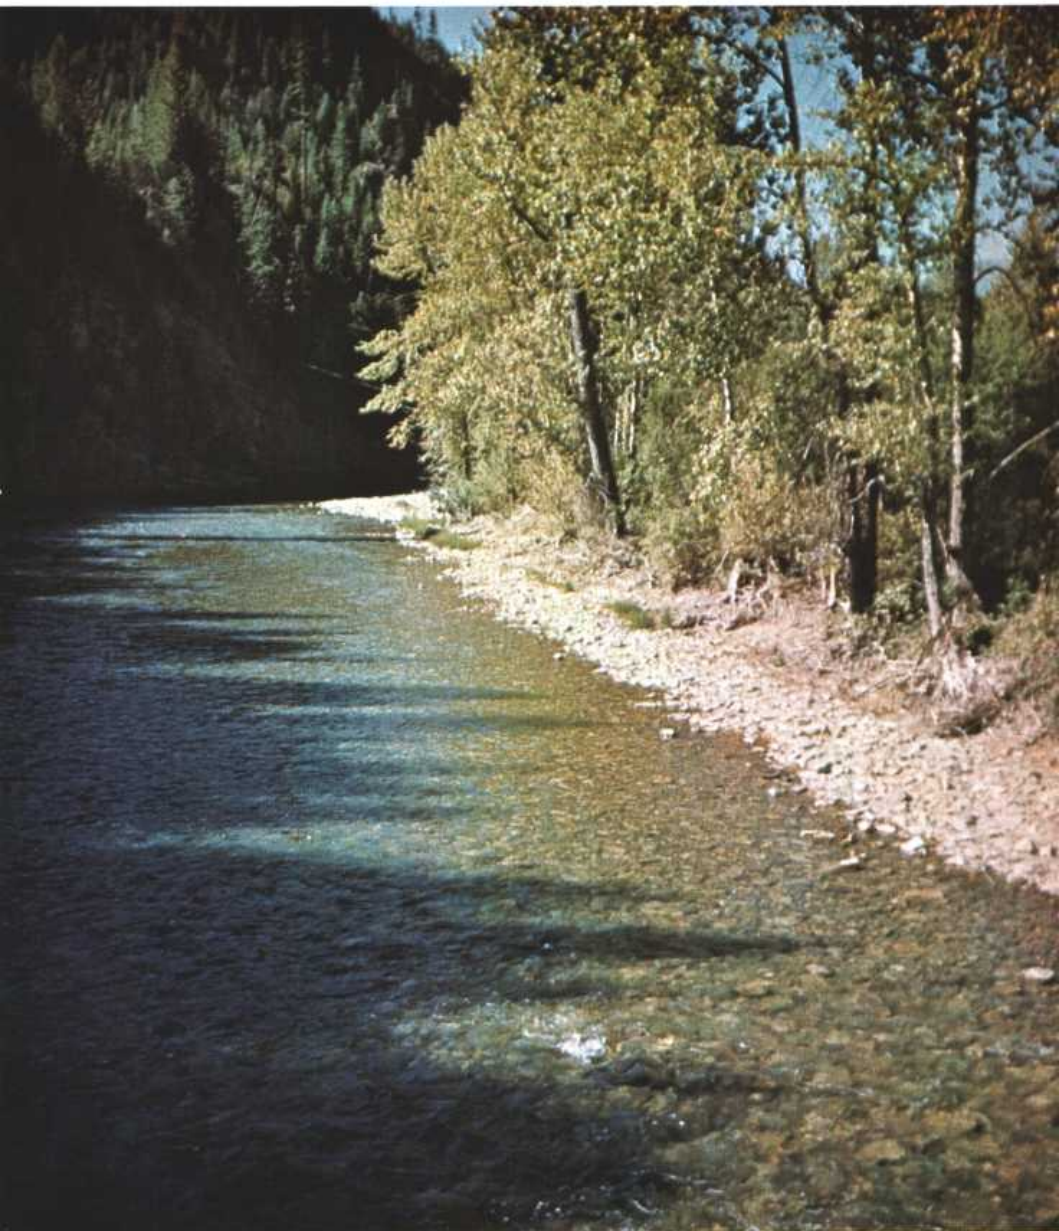
No. 36 downstream along right bank at section 1,  
Coeur d'Alene River near Pritchard, Idaho.

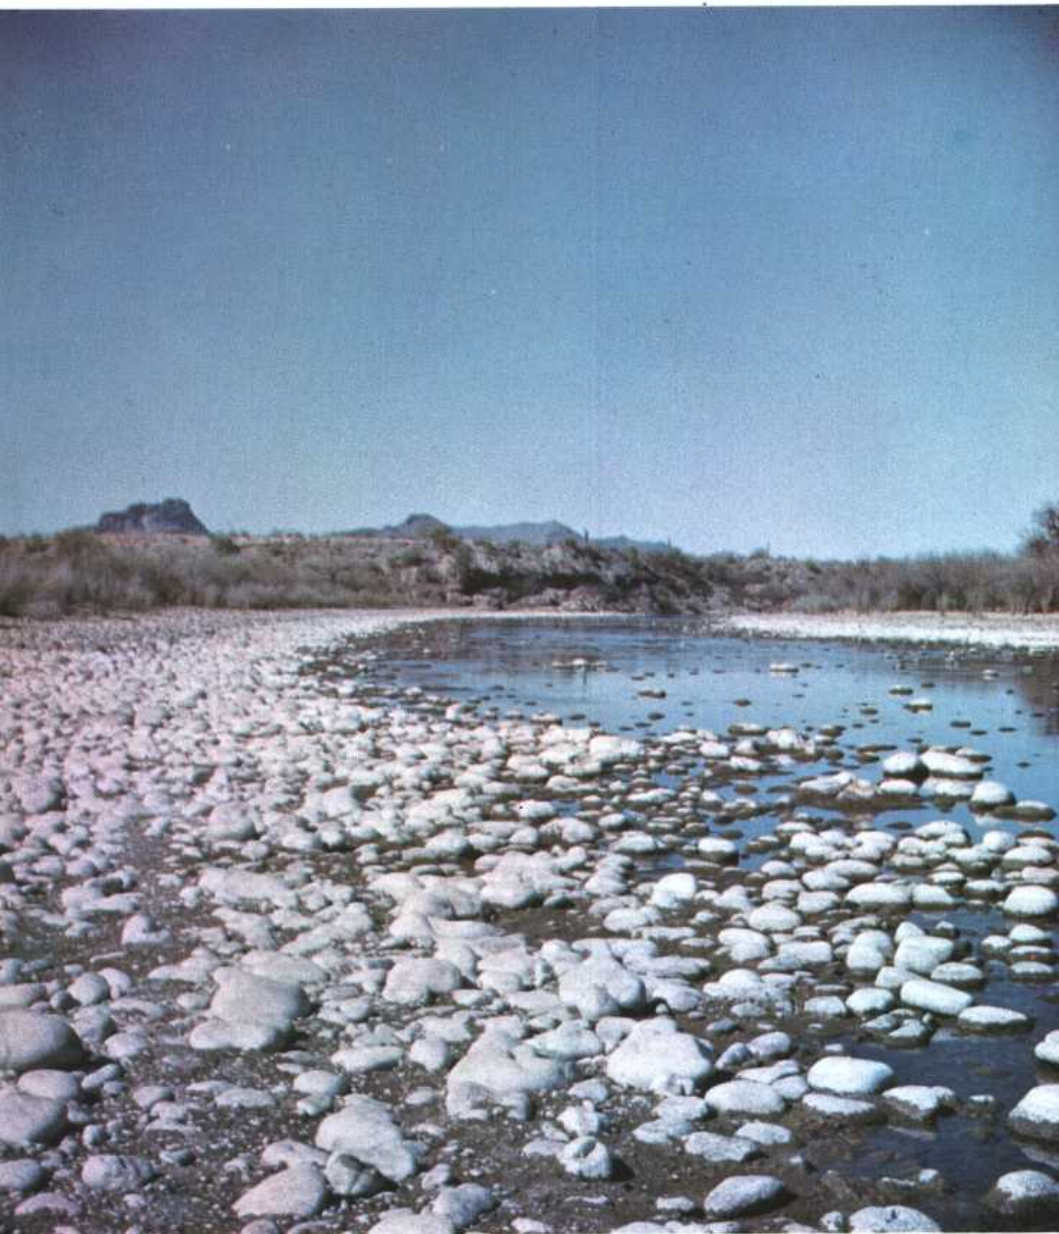
No. 818 downstream along left bank from section 2, Salt River below Stewart Mountain Dam, Ariz.

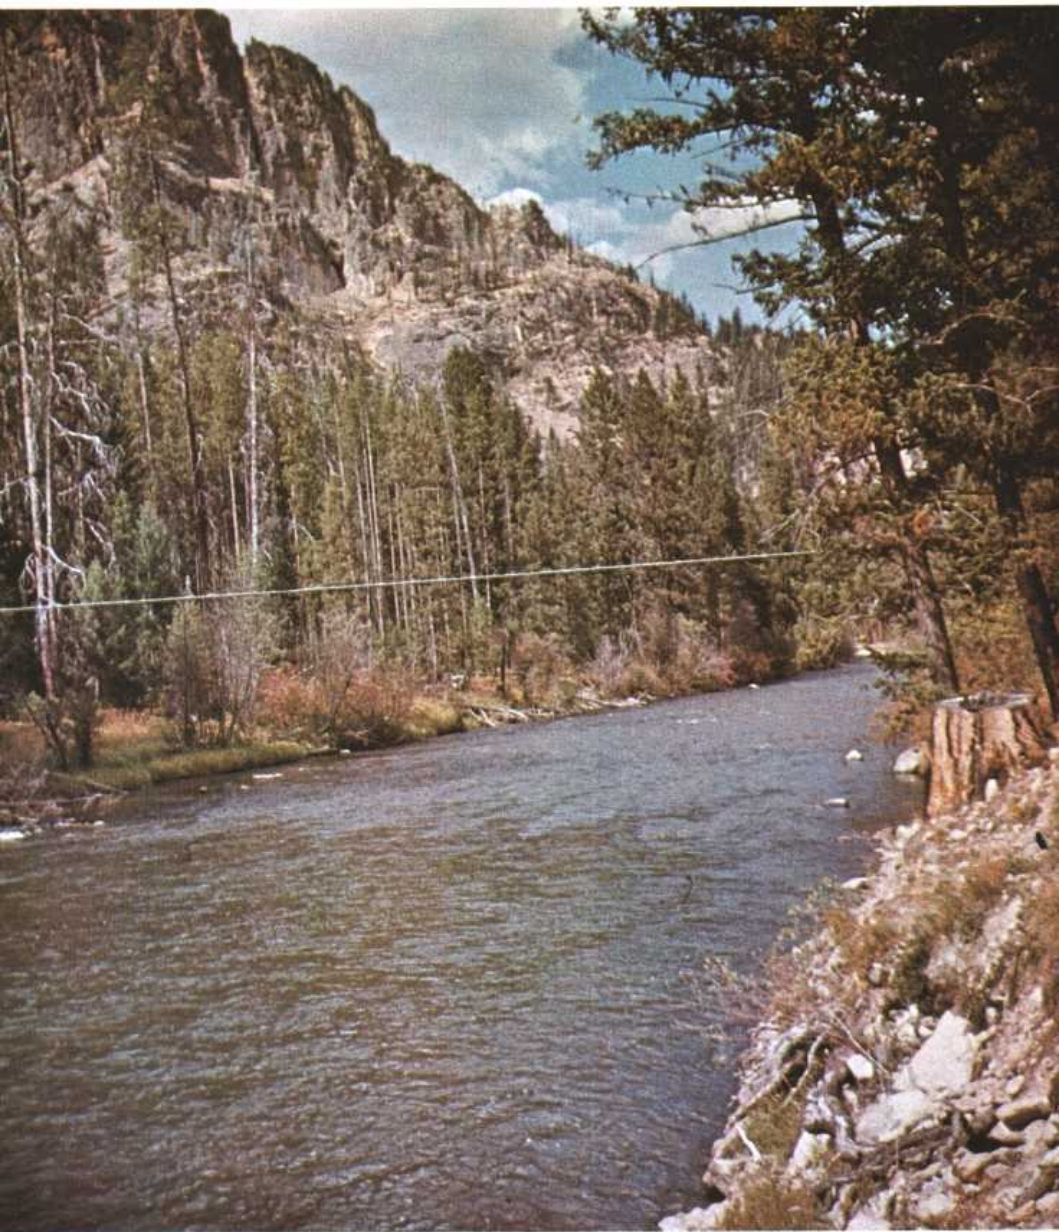
No. 177 downstream from right bank above section 1, West Fork Bitterroot River near Conner, Mont.

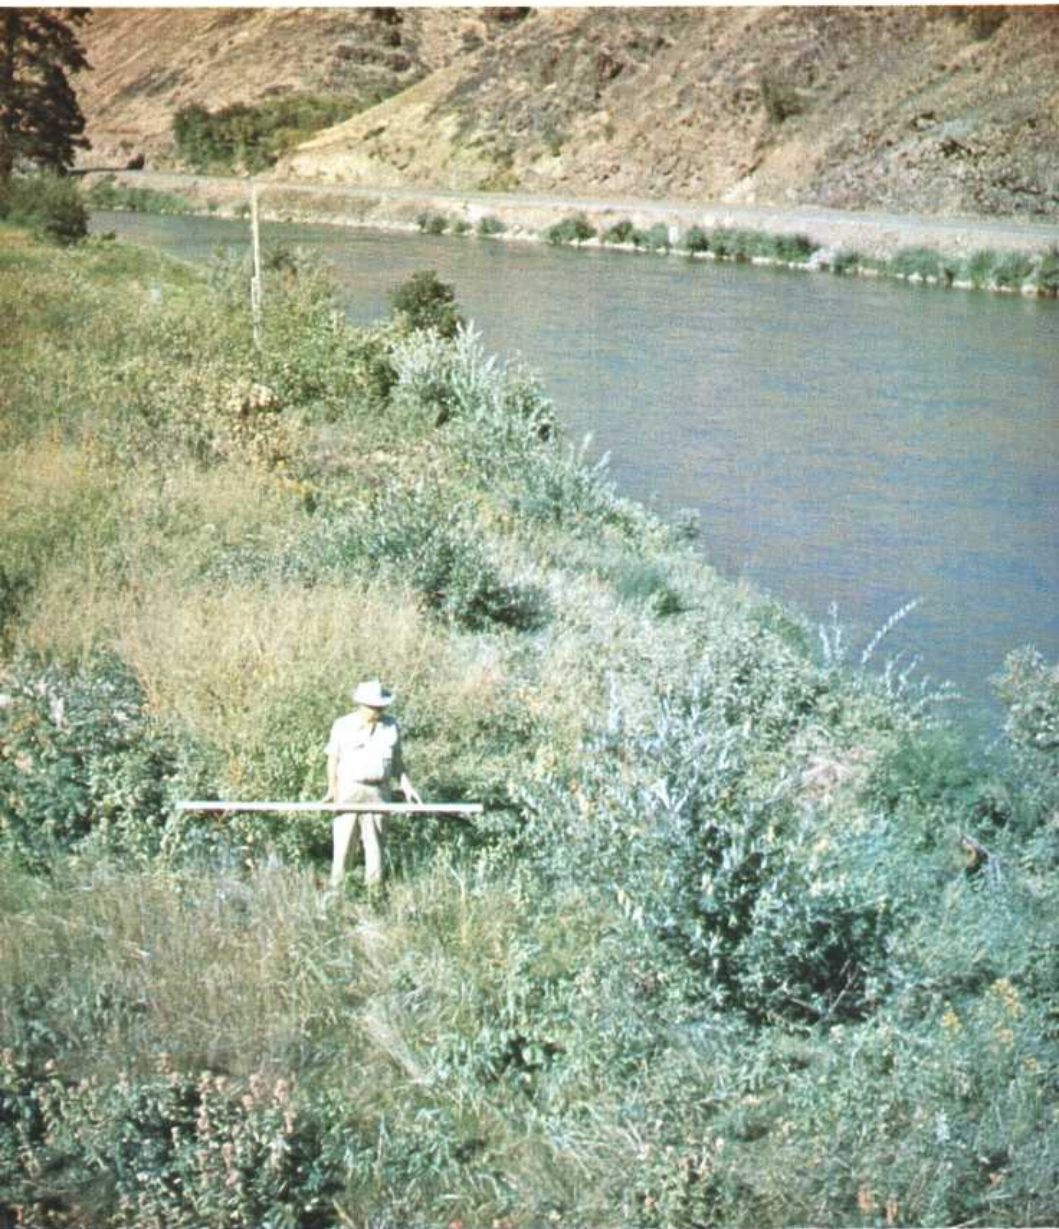
No. 187 upstream along right bank from below section 3,  
Yakima River at Umtanum, Wash.

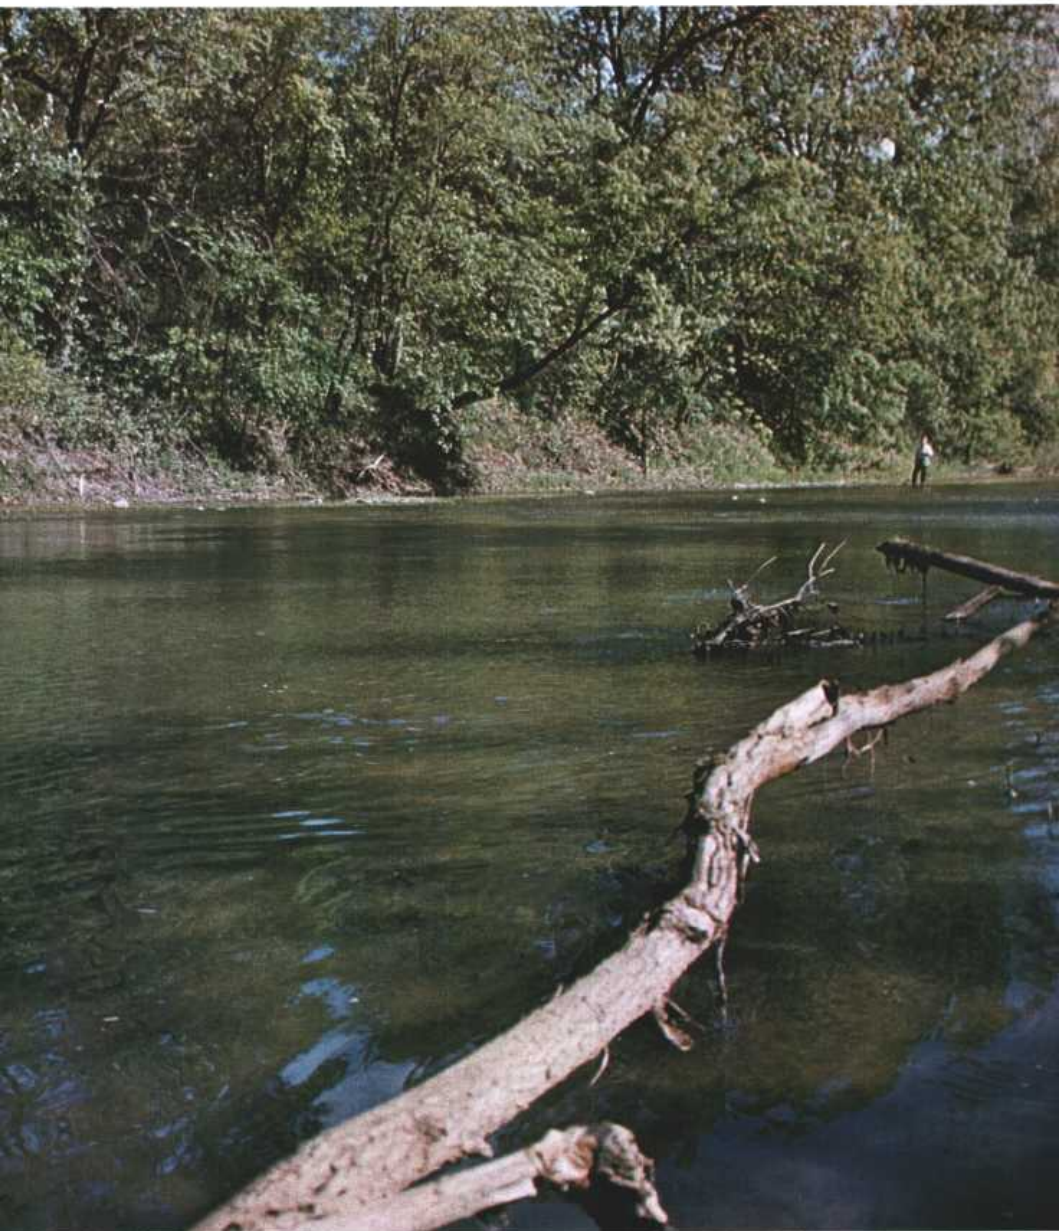
No. 837 downstream from right bank at section 1, Middle Fork Vermilion River near Danville, Ill.

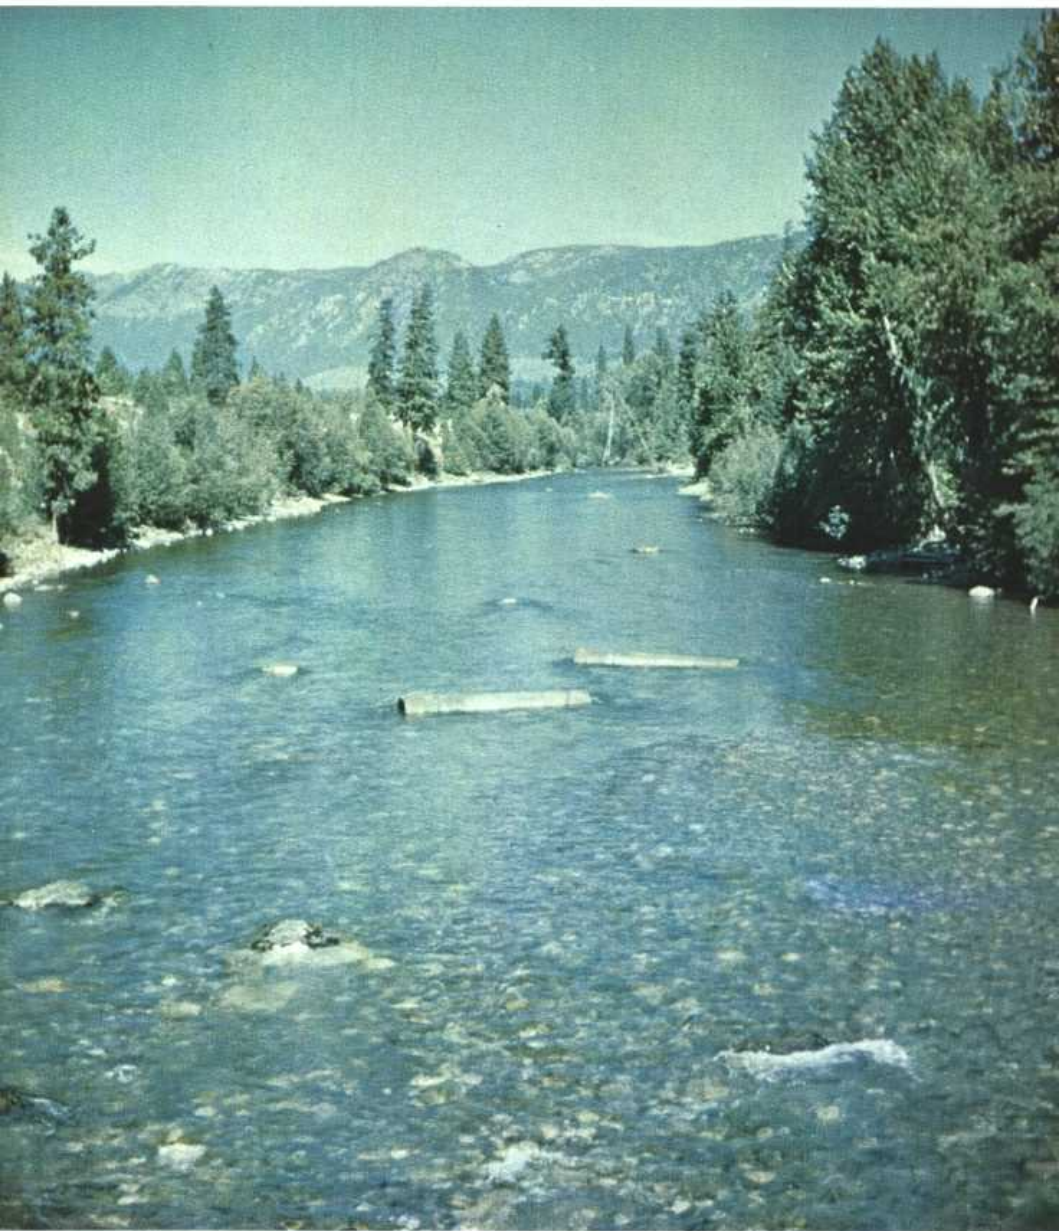
No. 169 downstream from above section 1, Wenatchee River  
at Plain, Wash.

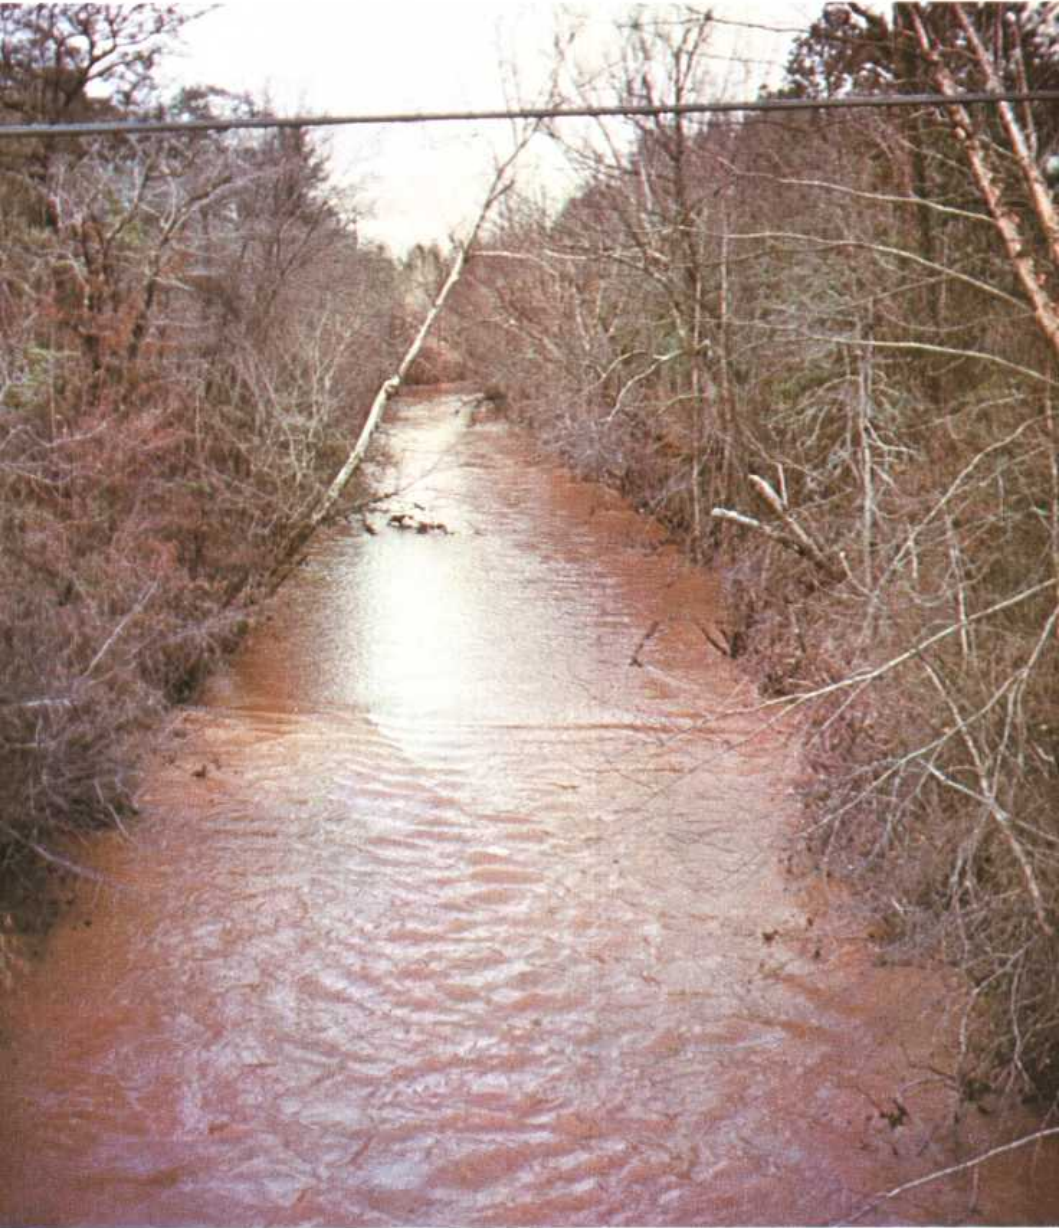
No. 1173 upstream from bridge section 12, Tobesofkee Creek near Macon, Ga.

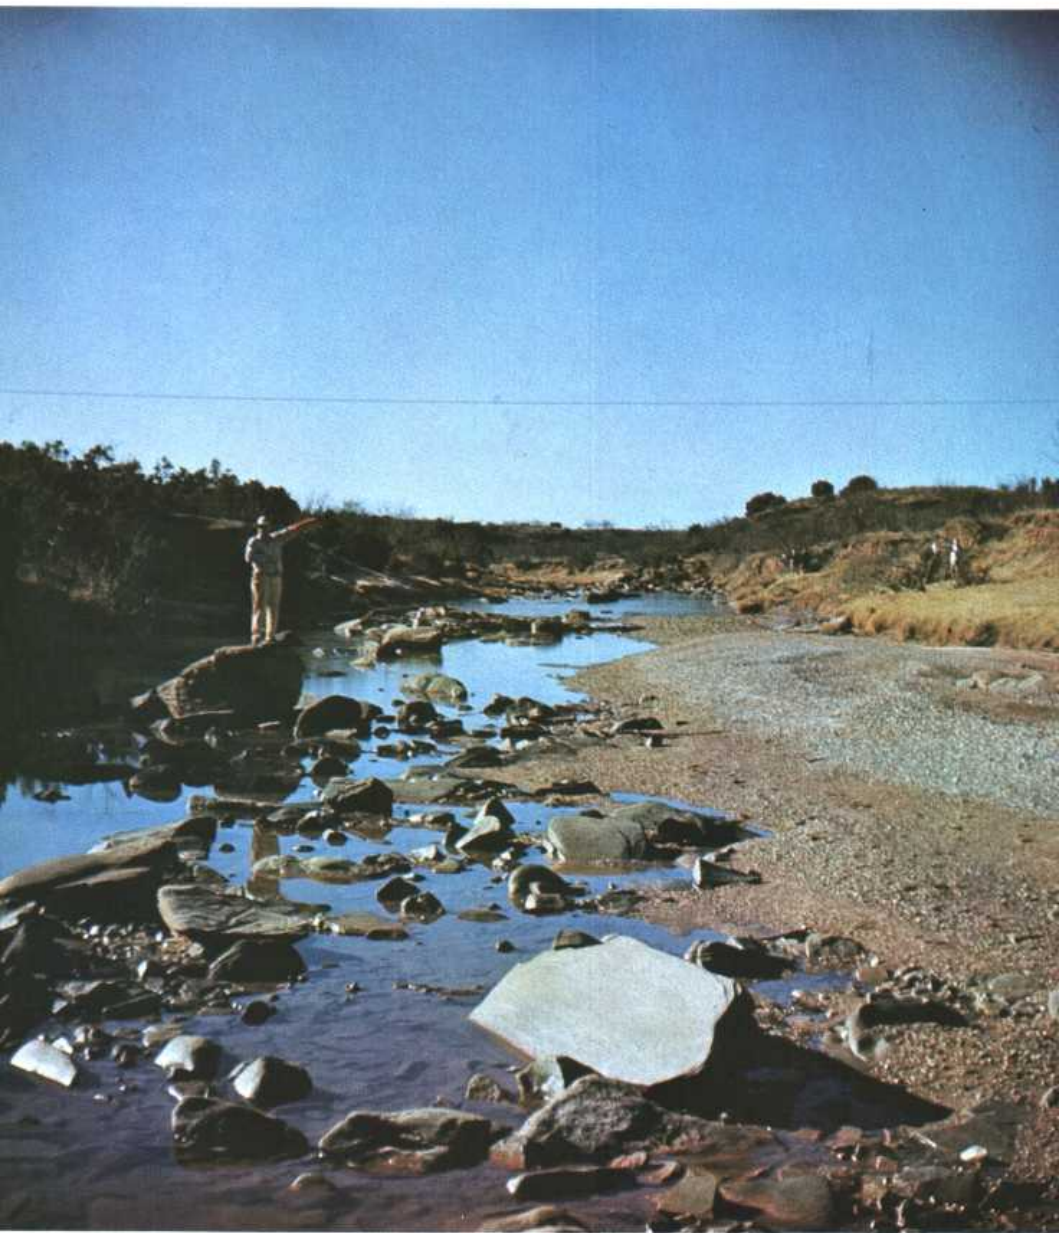
No. 345 upstream from below section 2, Bull Creek  
near Ira, Tex.

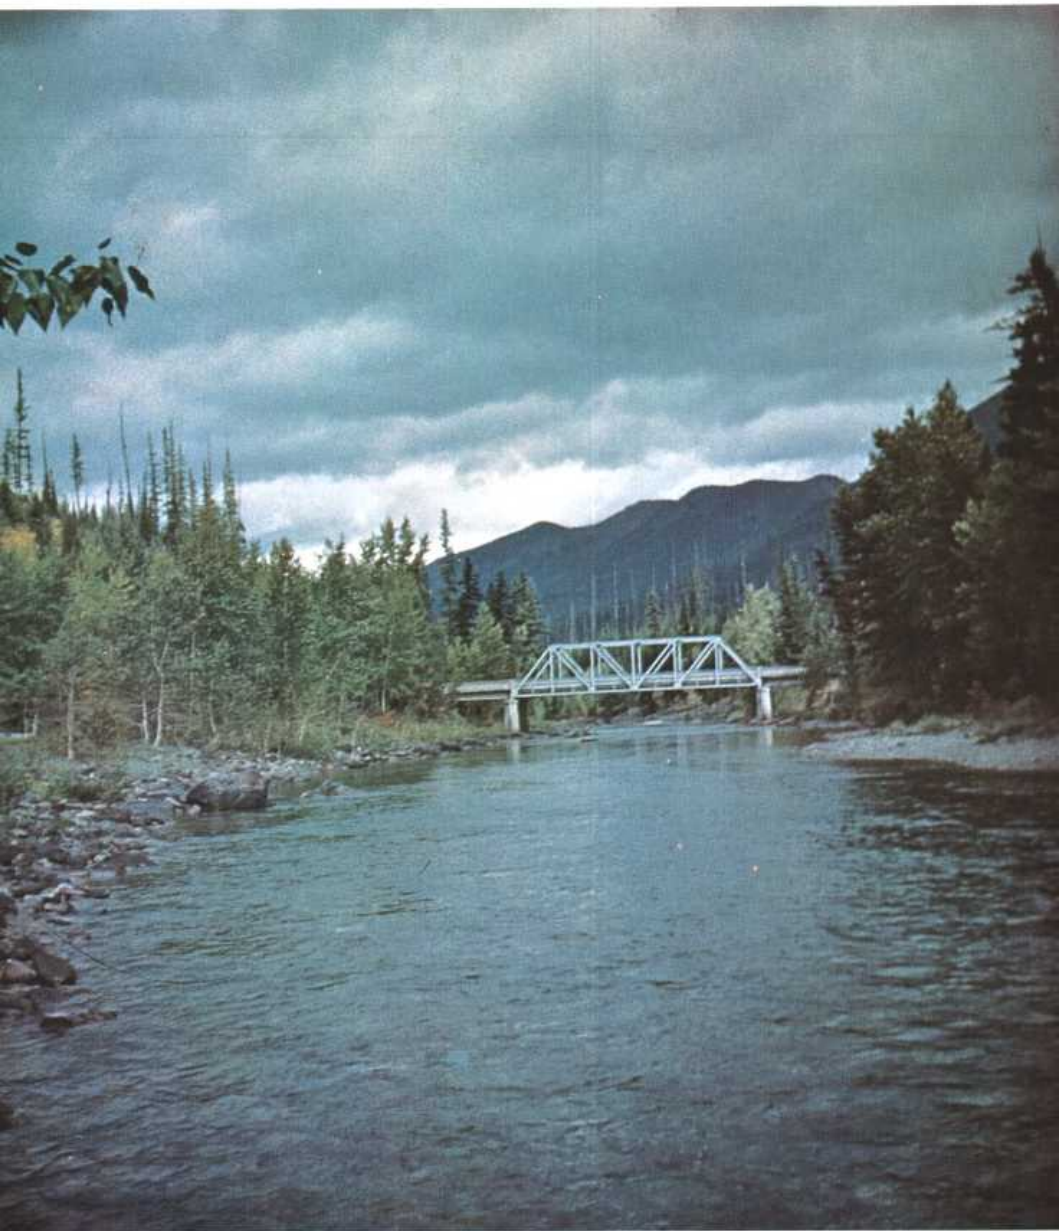
No. 117 downstream from section 1, Middle Fork Flathead River near Essex, Mont.

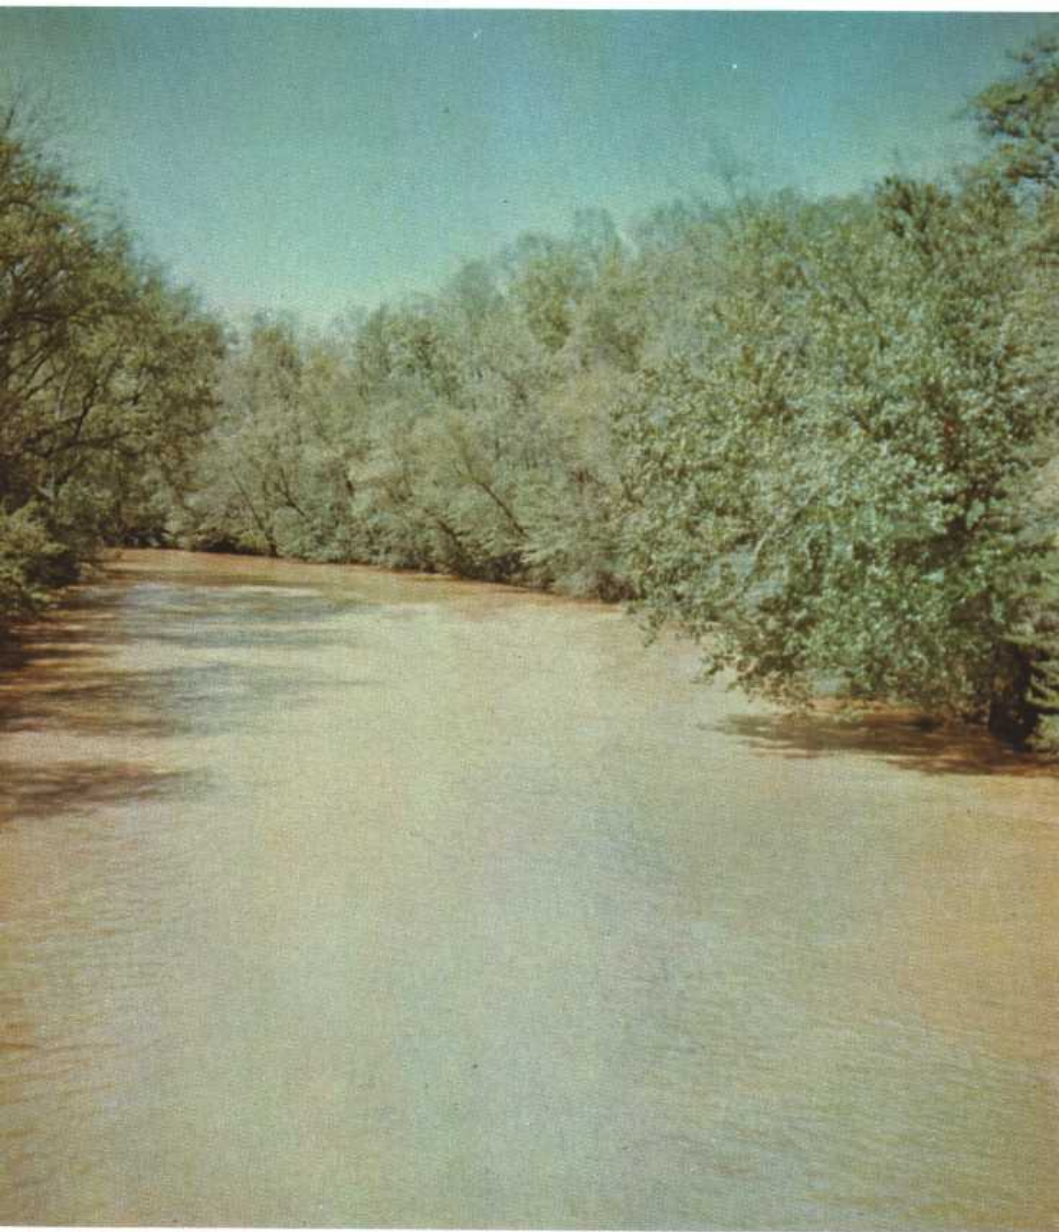
No. 1174 downstream from above section 4, Middle Oconee  
River near Athens, Ga.

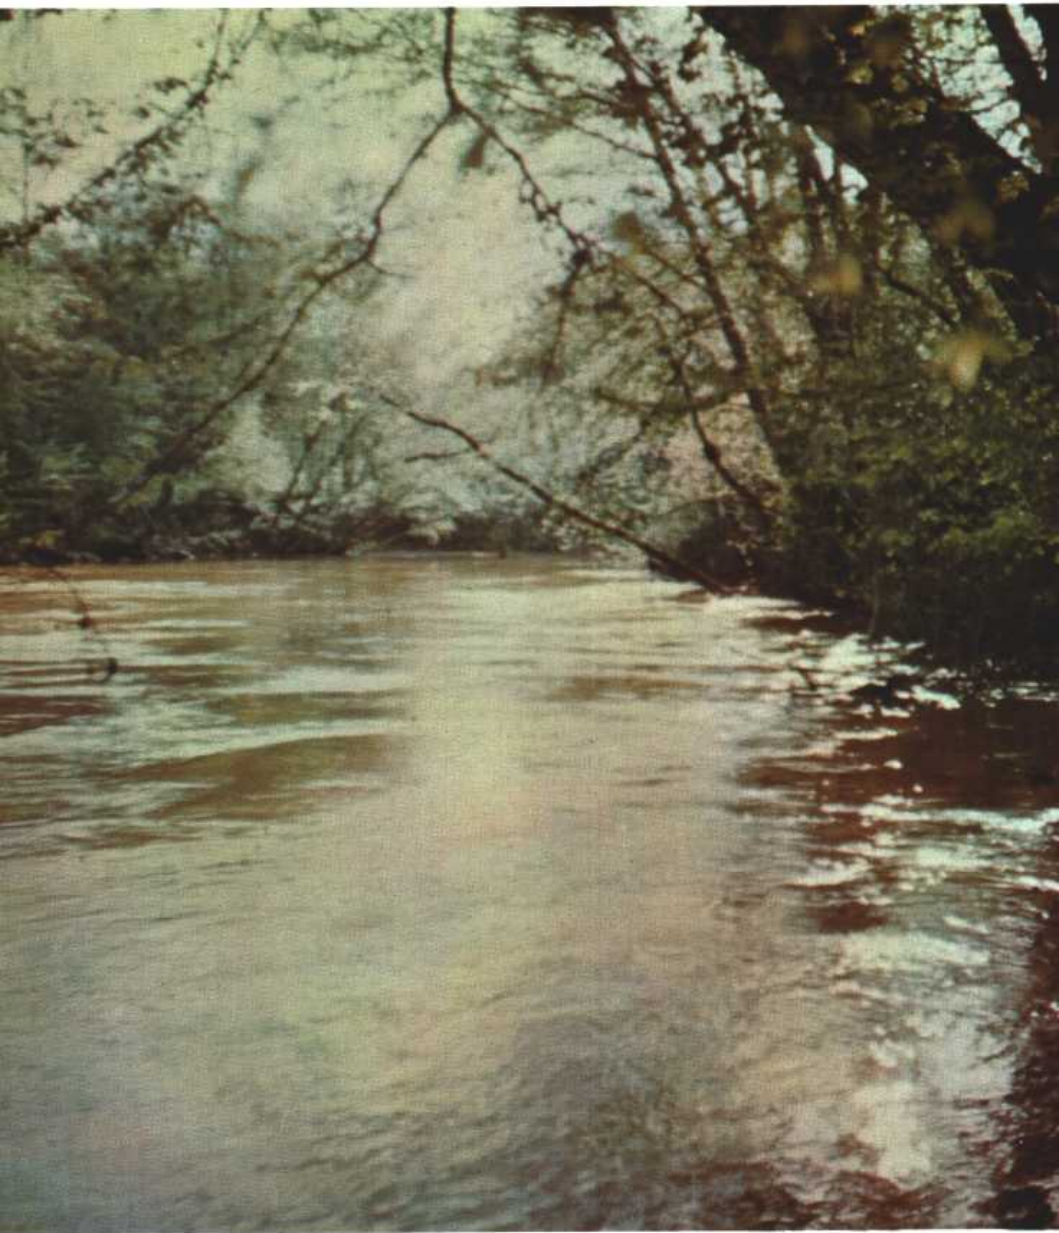
No. 1175 upstream from right bank at section 7, Middle Oconee River near Athens, Ga.

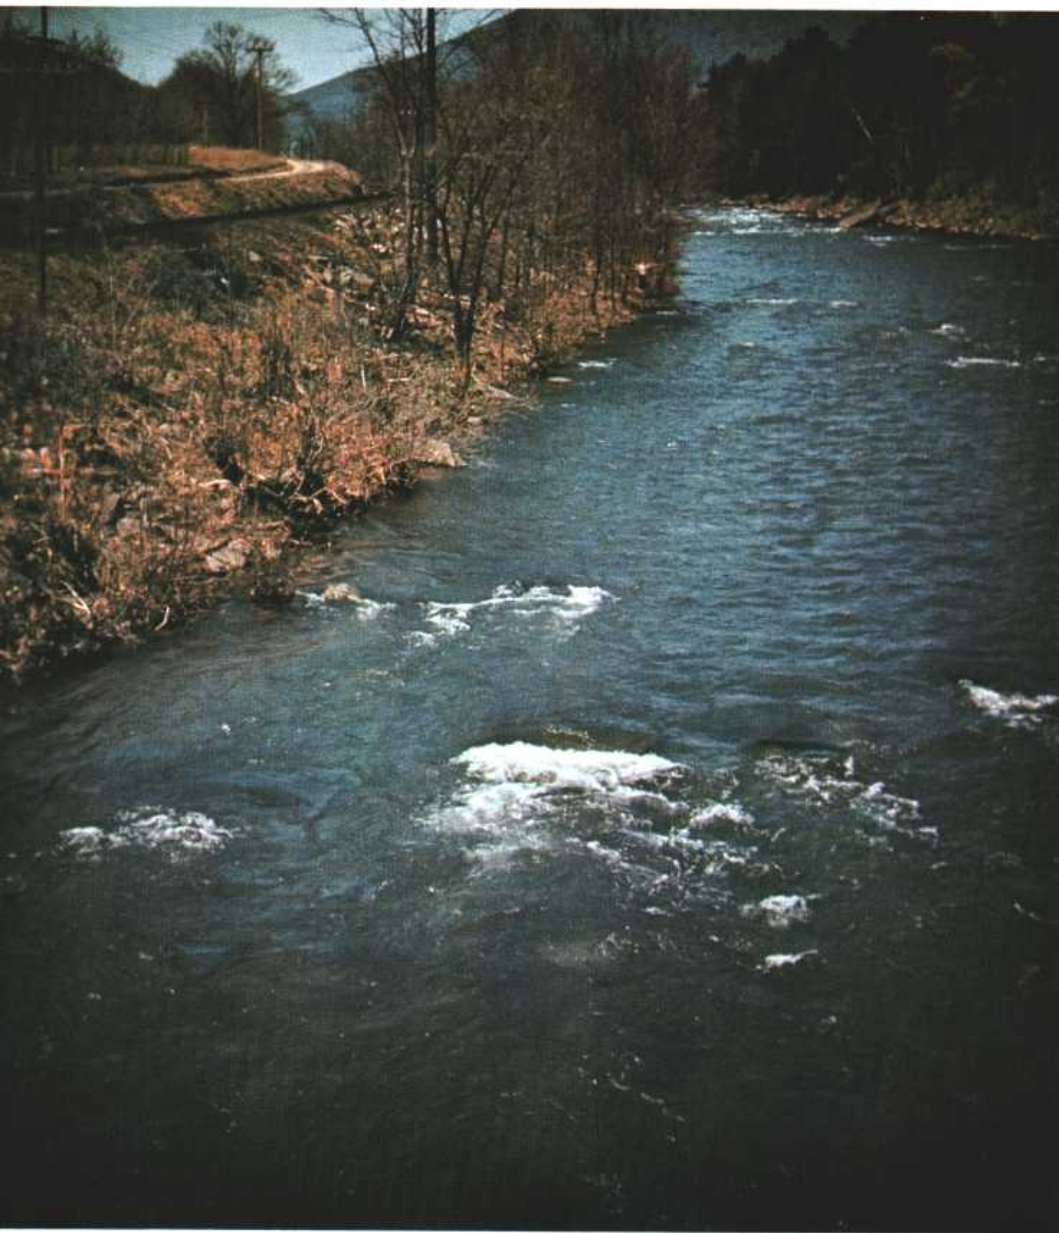
No. 358 upstream along right bank from below reach,  
Esopus Creek at Coldbrook, N.Y.
