# Roughness Characteristics of Natural Channels

By HARRY H. BARNES, JR.

U.S. GEOLOGICAL SURVEY WATER-SUPPLY PAPER 1849

*Color photographs and descriptive  
data for 50 stream channels for  
which roughness coefficients have  
been determined*

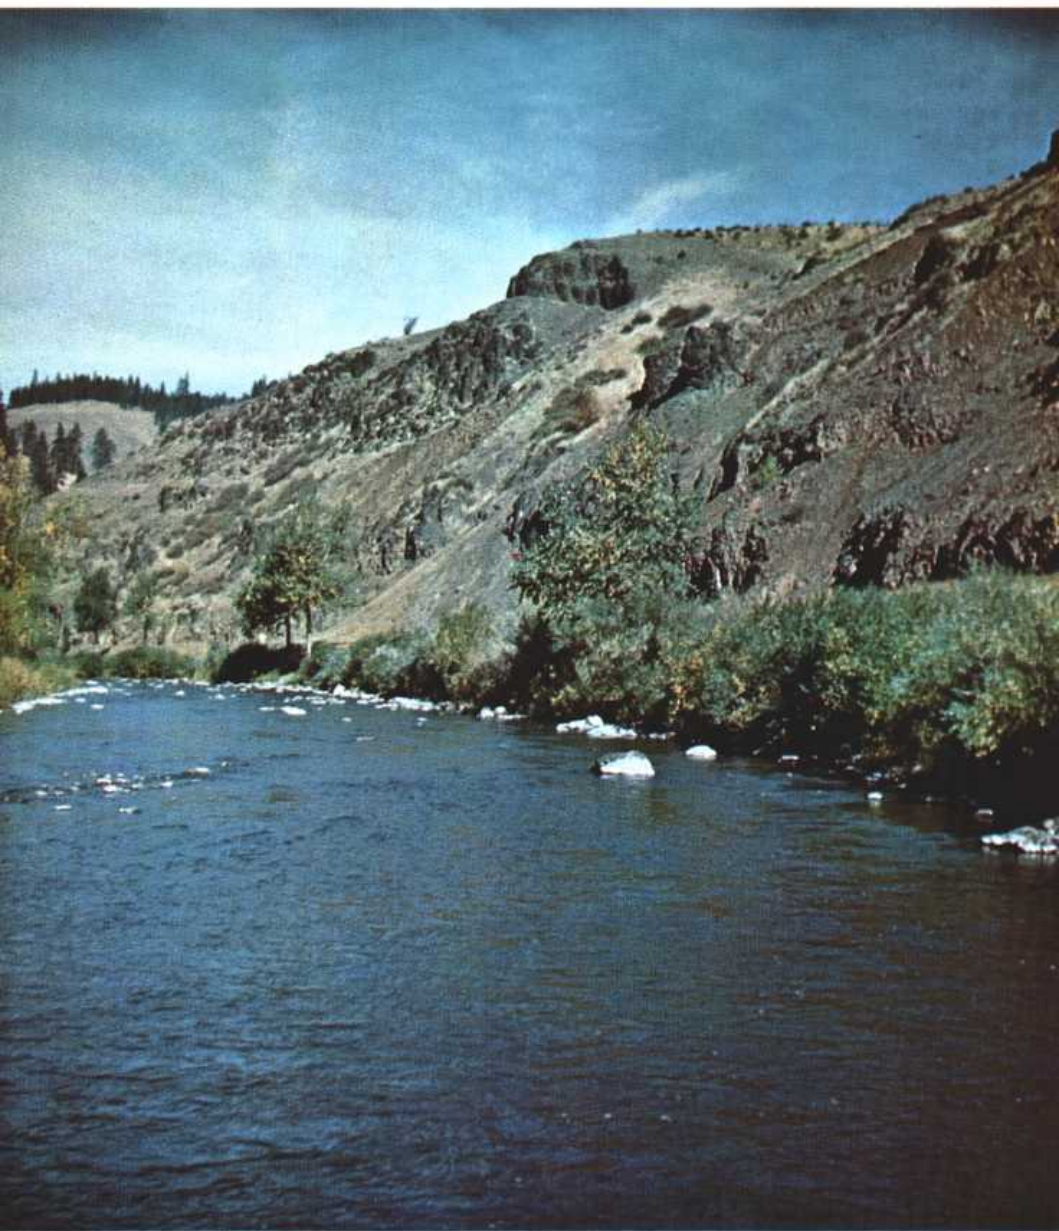
No. 78 upstream along left bank from channel below section 3,  
Grande Ronde River at La Grande, Oreg.

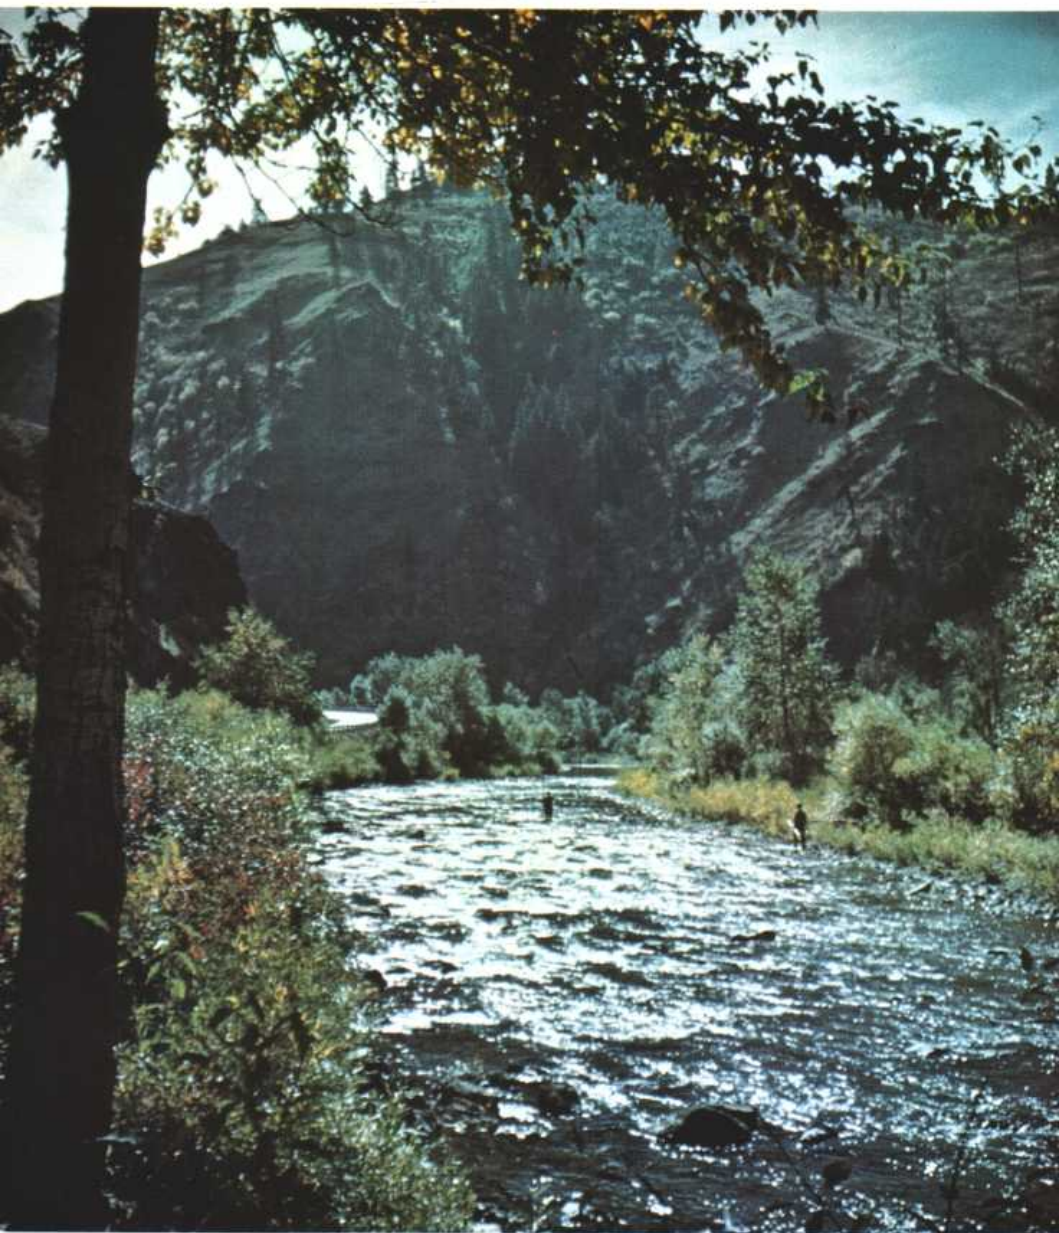
No. 80 downstream from left bank above section 1,  
Grande Ronde River at La Grande, Oreg.

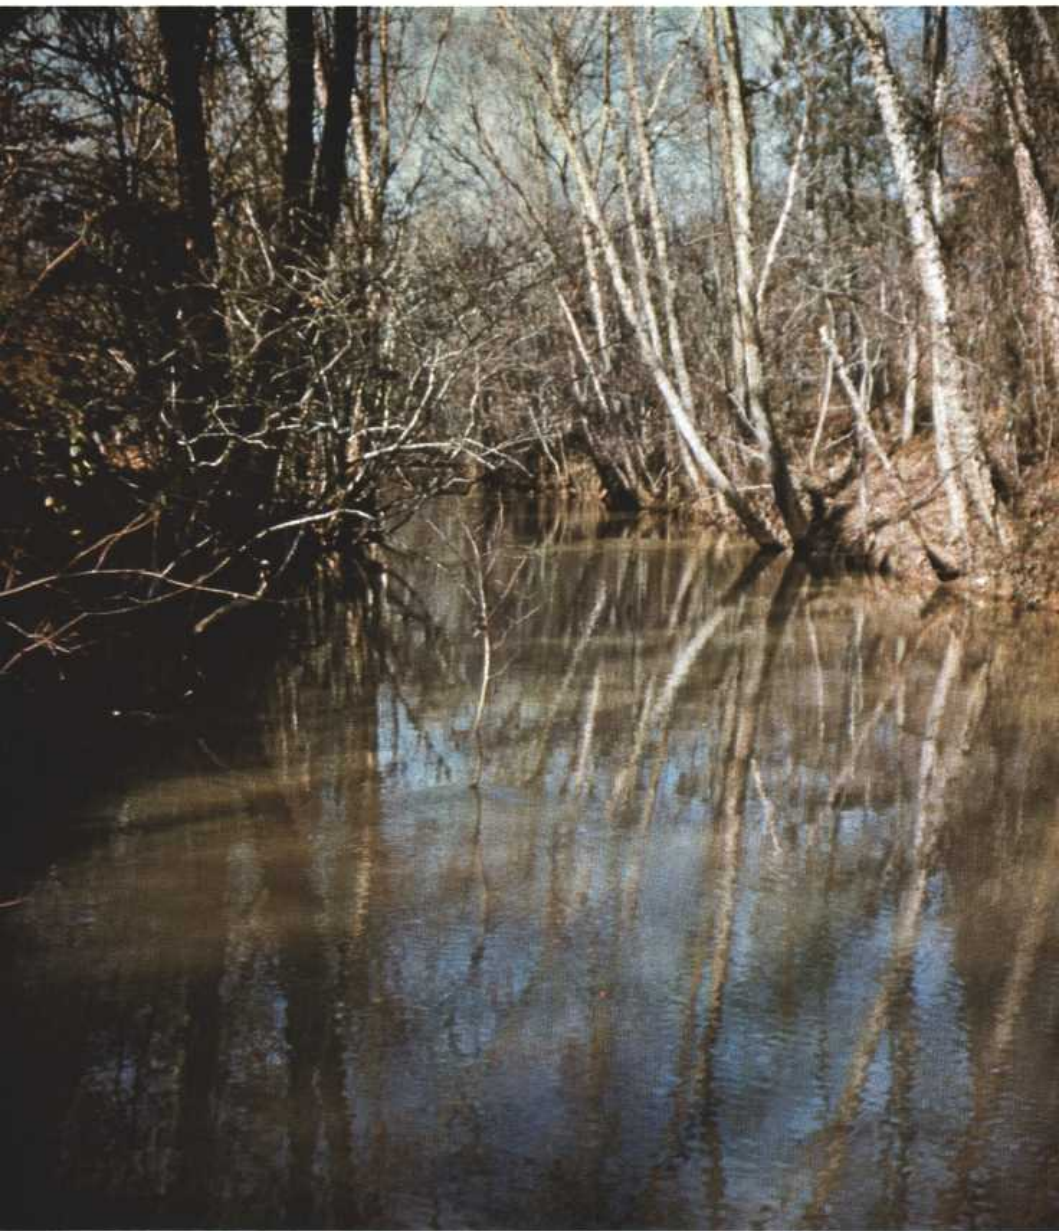
No. 1176 upstream from right bank at section 7,  
Murder Creek near Monticello, Ga.

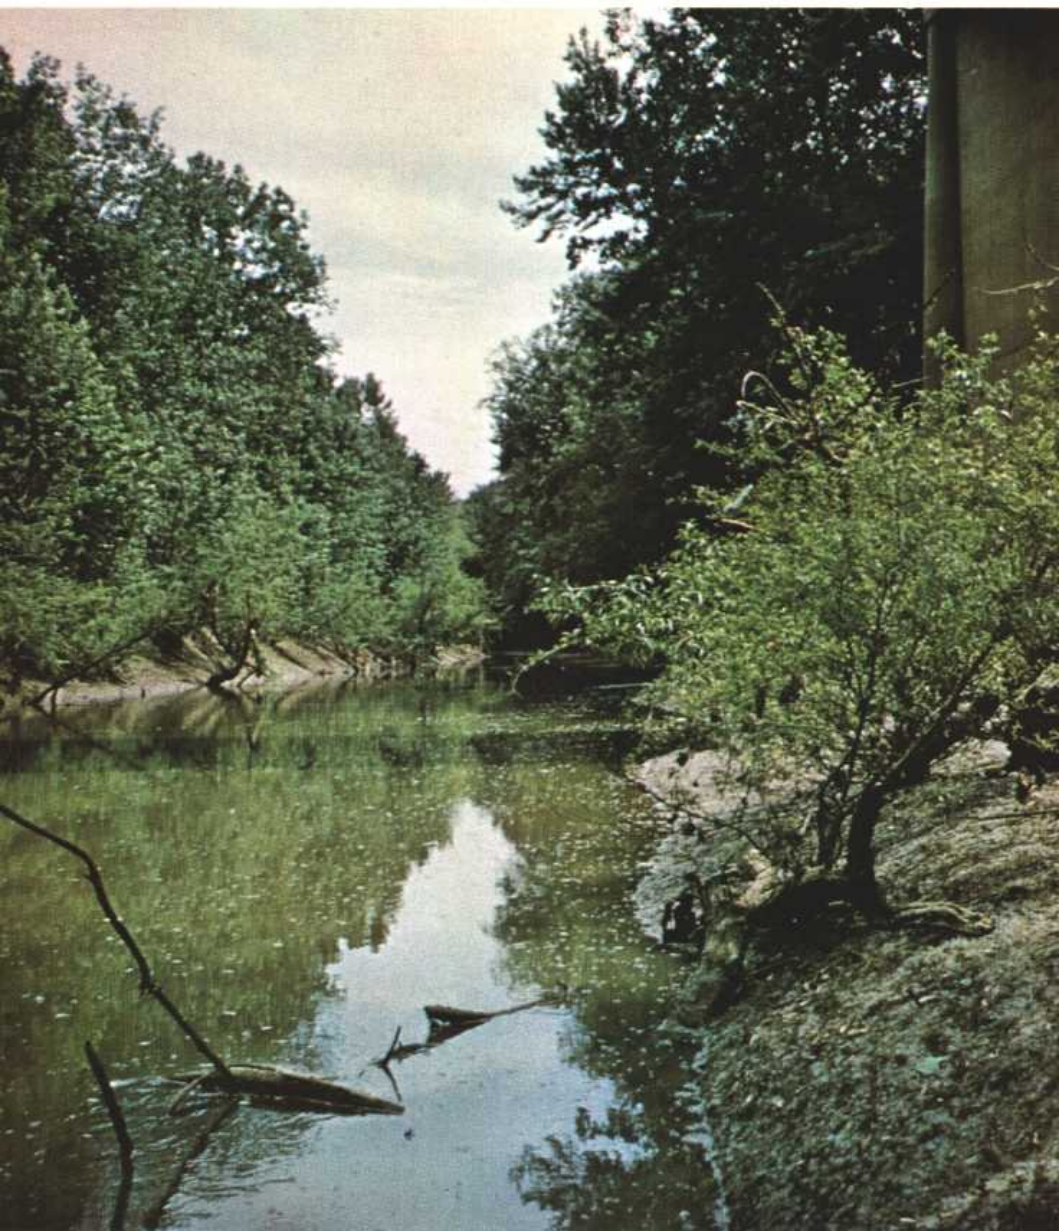
No. 1190 upstream from left bank below section 6,  
Rolling Fork at Boston, Ky.

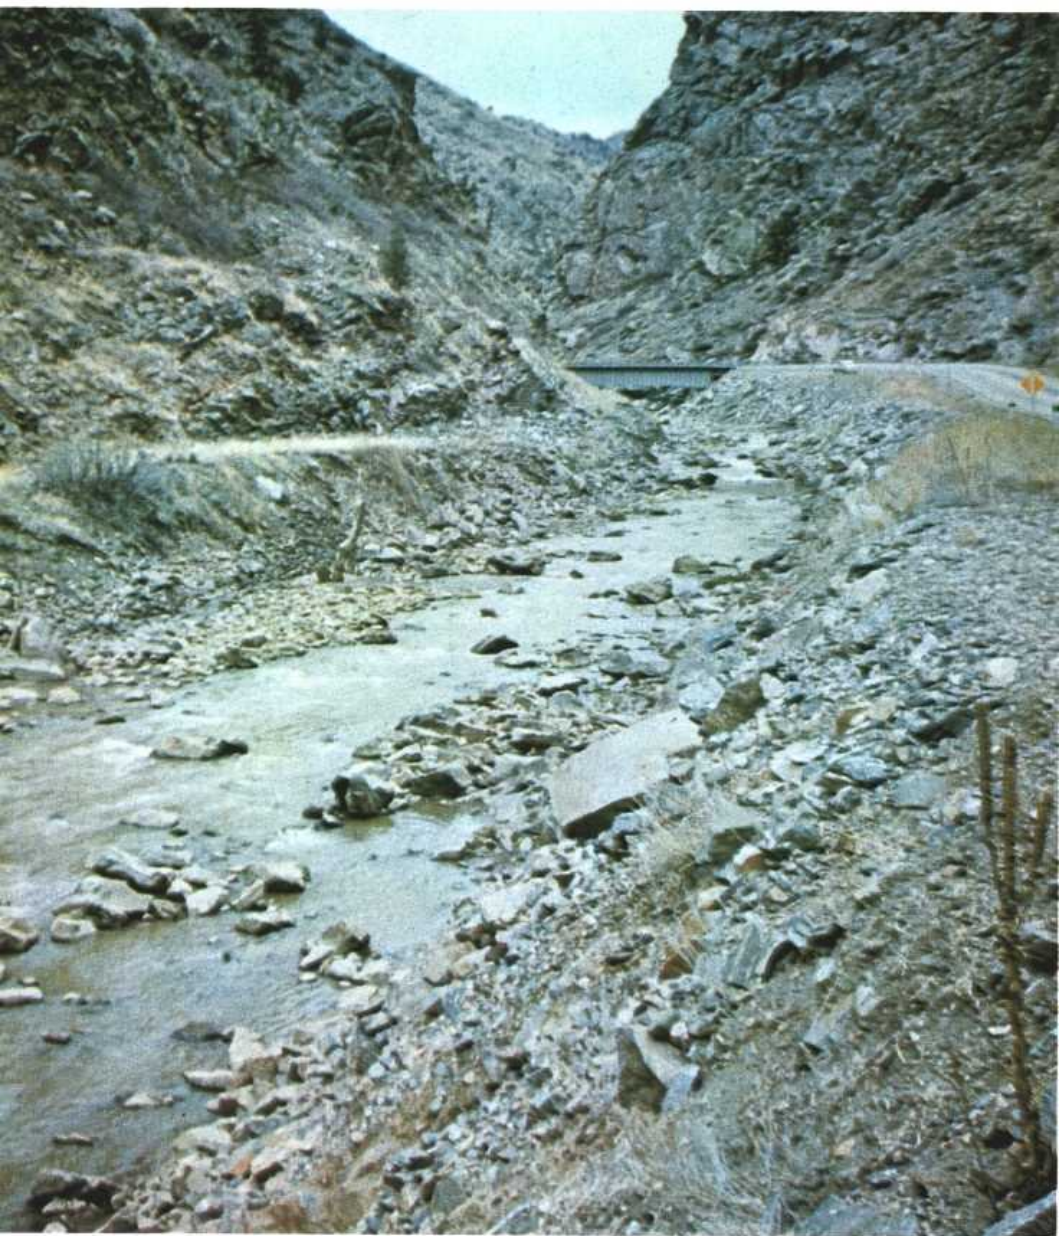
No. 1198 upstream from section 16, Clear Creek near Golden, Colo.

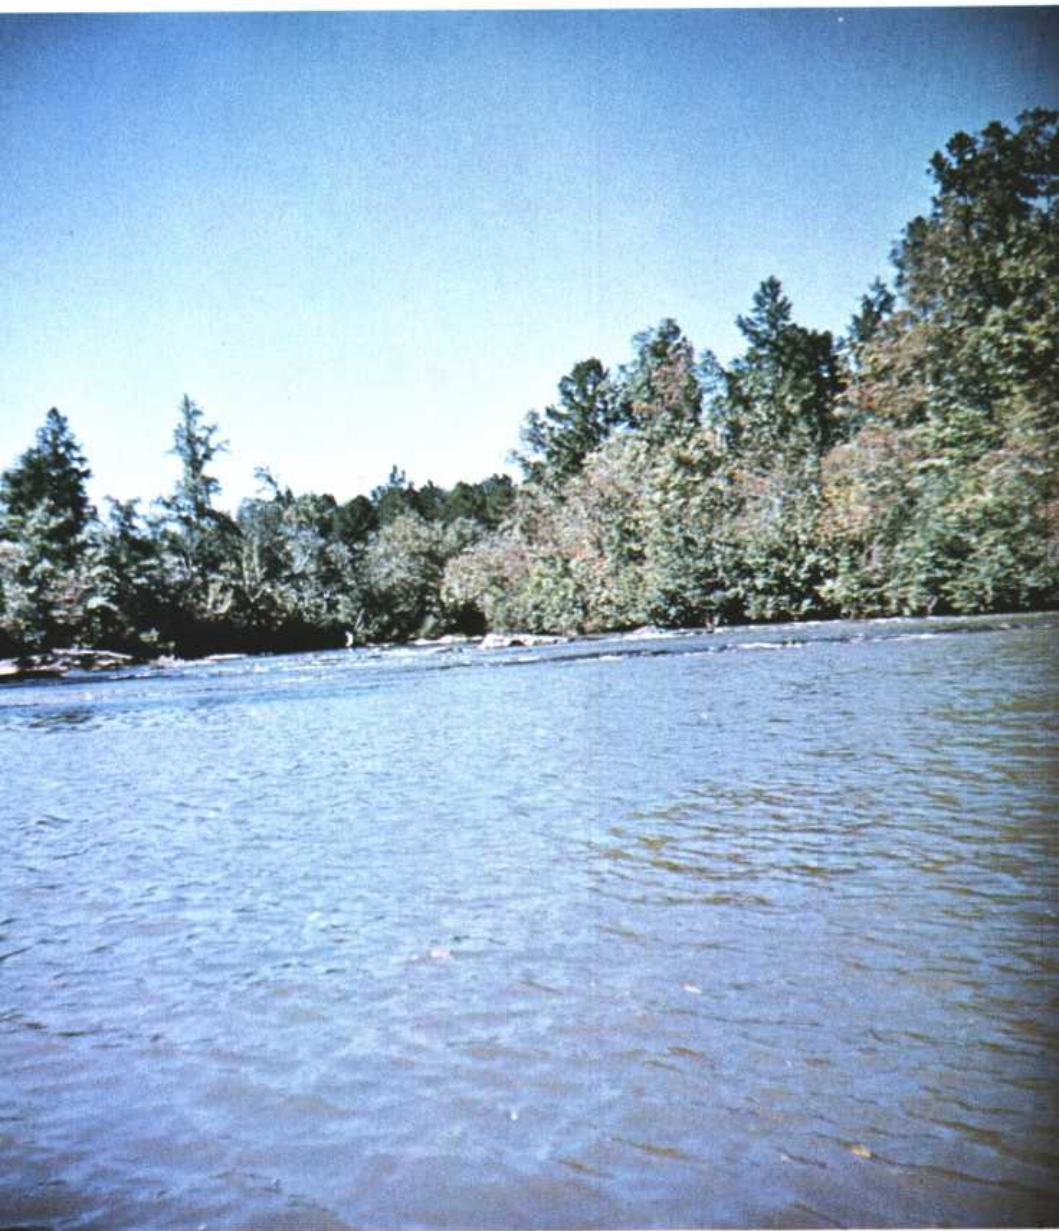
No. 1187 upstream from section 4,  
Chattahoochee River near Leaf, Ga.

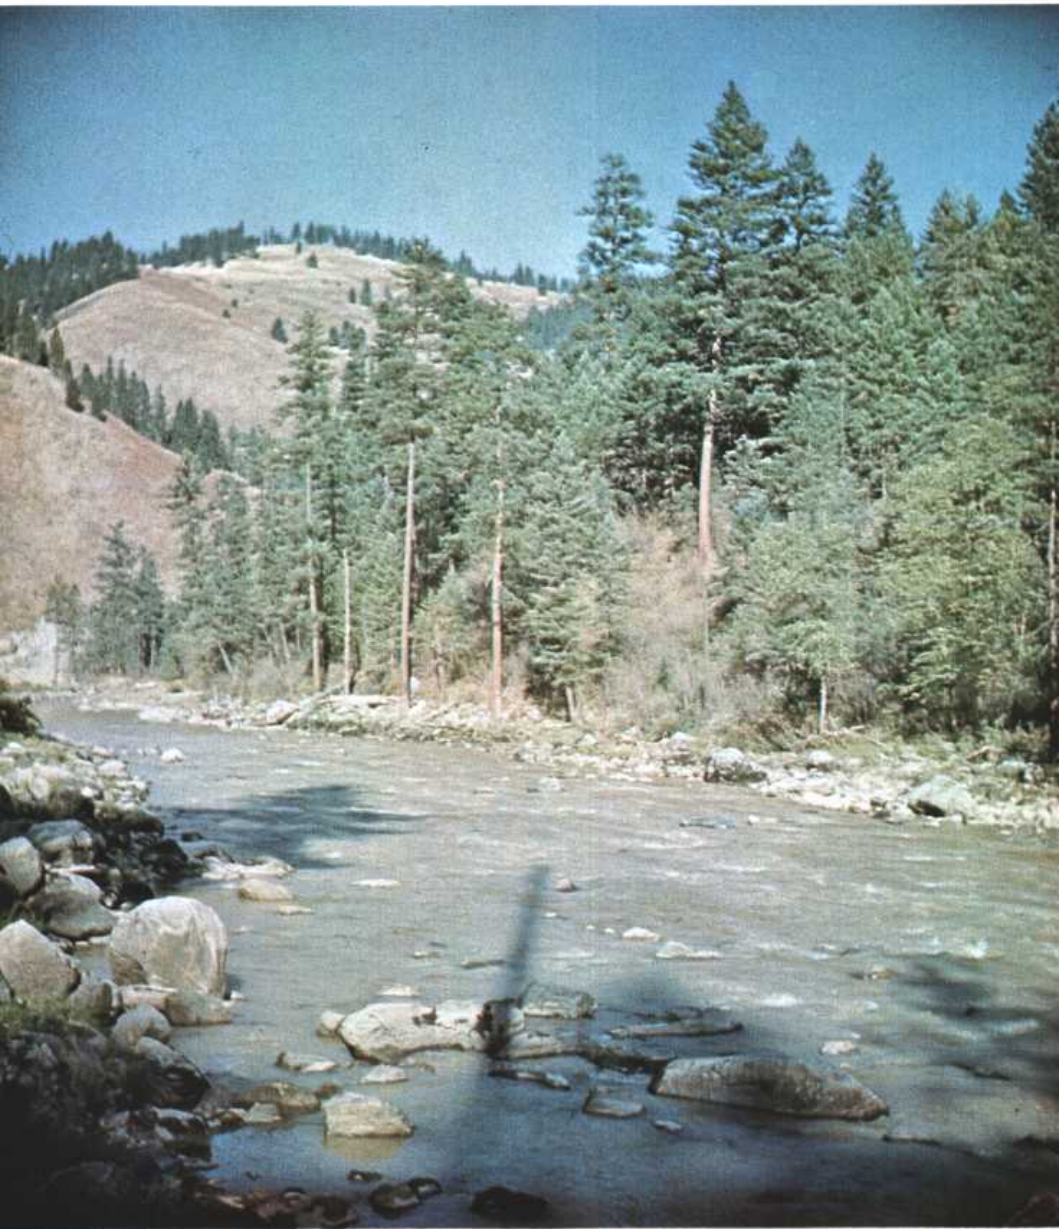
No. 156 downstream from left bank at section 2, South Fork Clearwater River near Grangeville, Idaho.

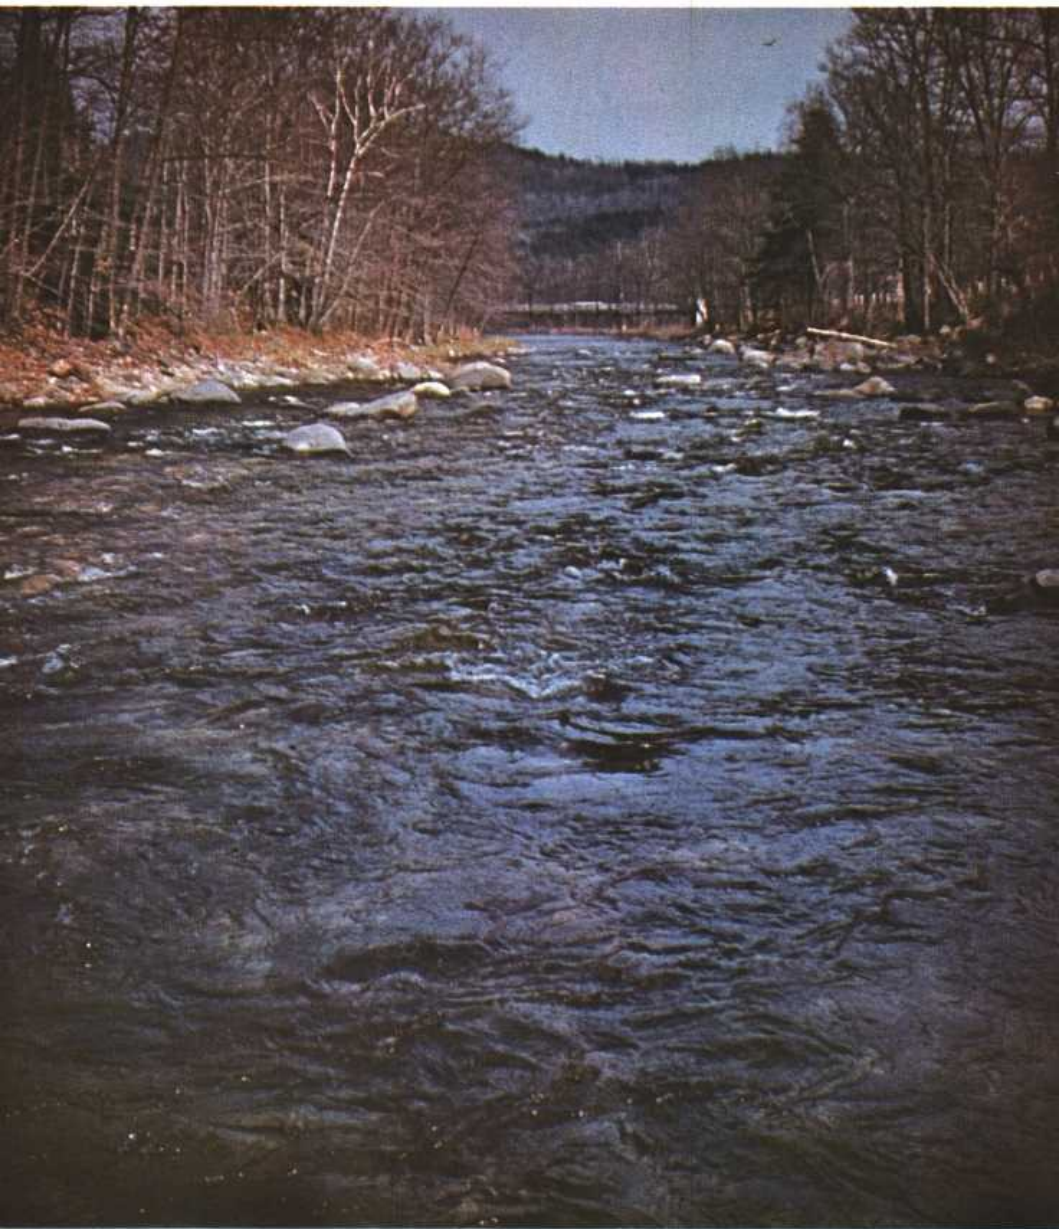
No. 315 downstream from above section 1, Middle Branch  
Westfield River at Goss Heights, Mass.

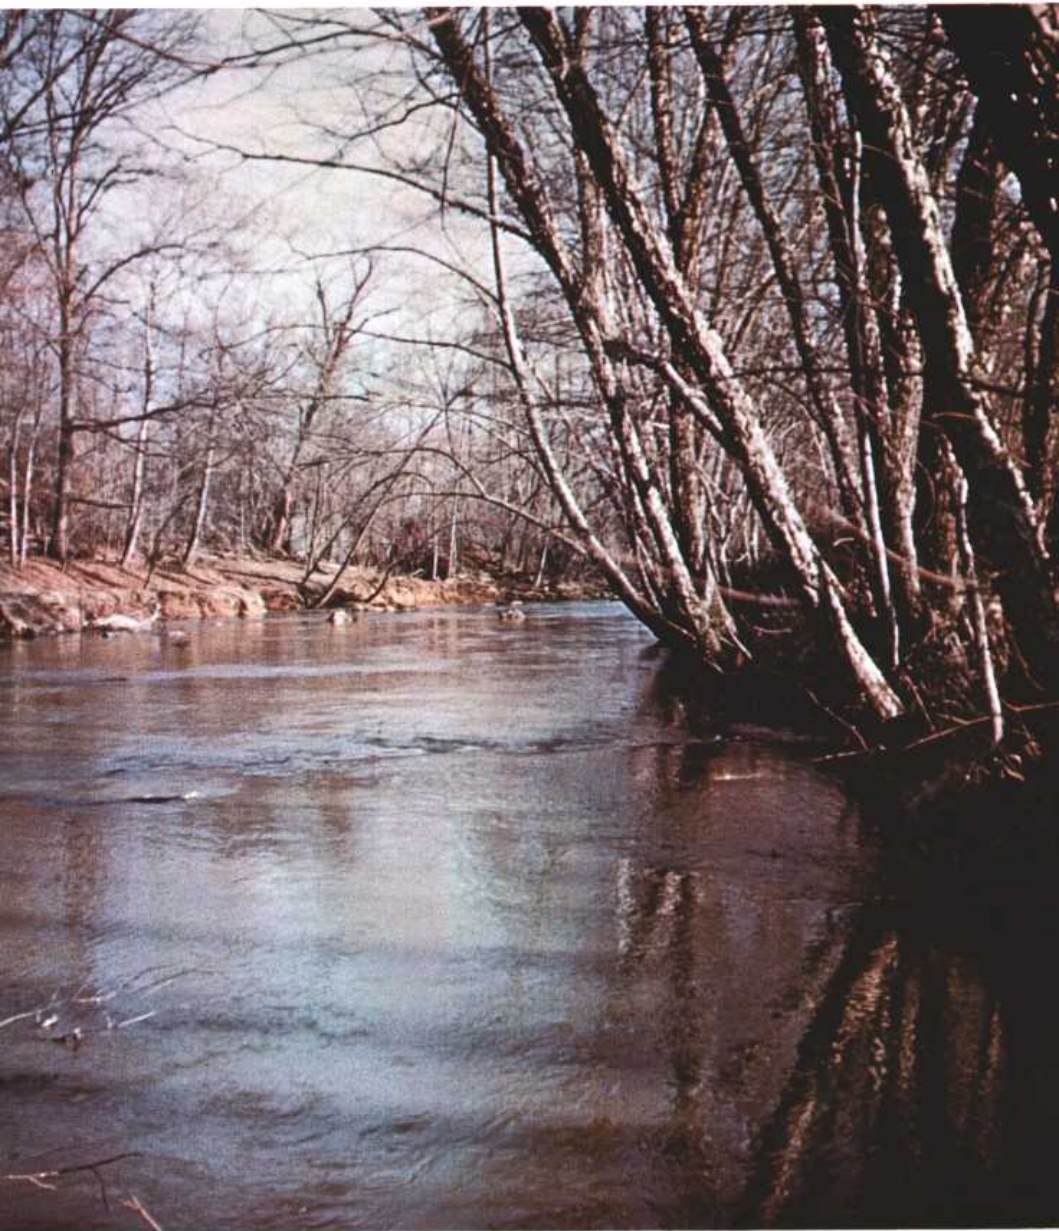
No. 1183 downstream along right bank from section 6,  
Haw River near Benaja, N.C.

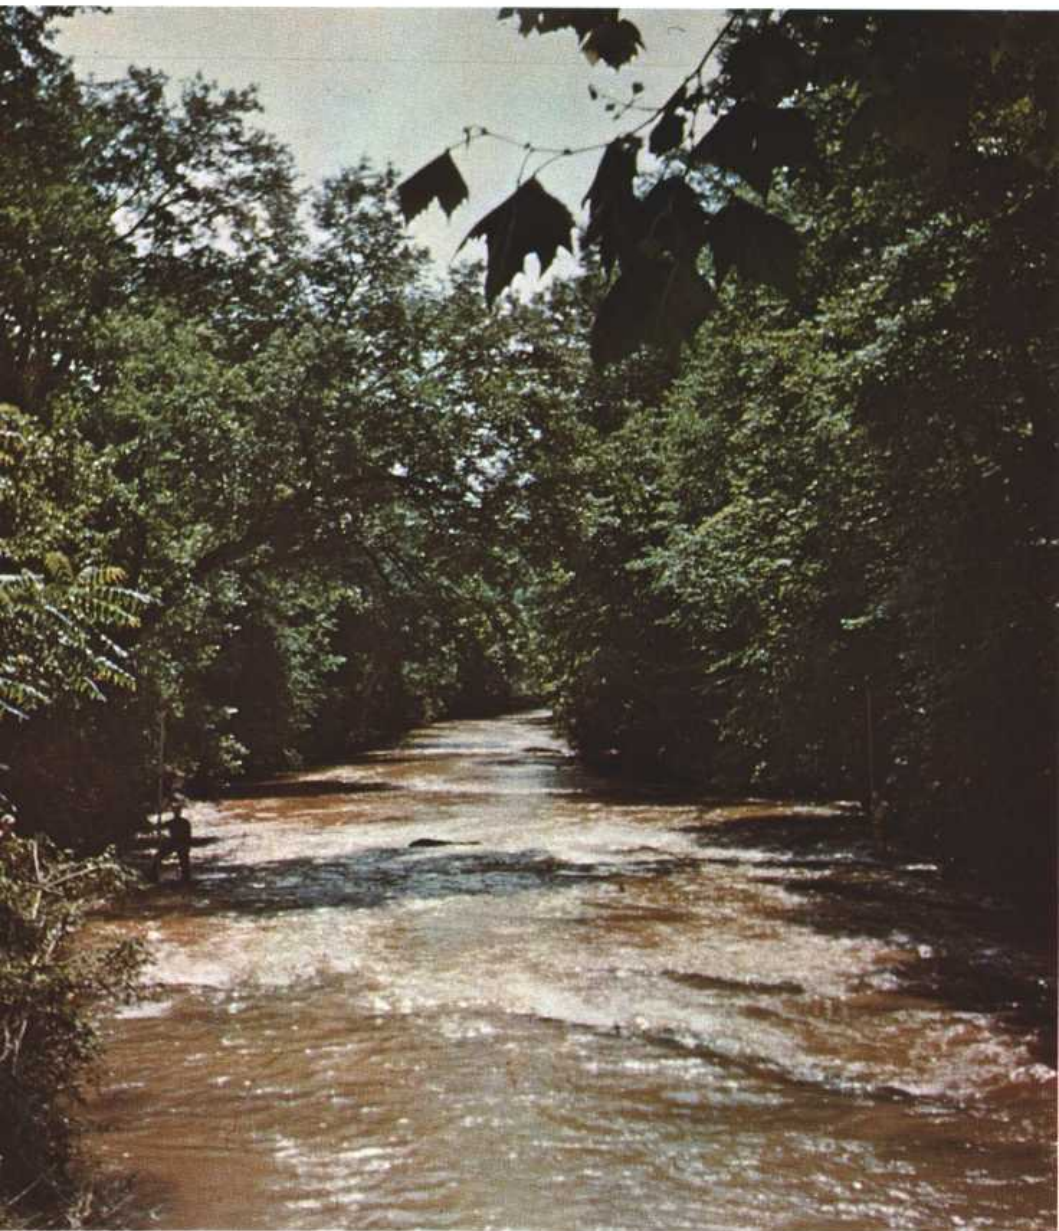
No. 431 downstream from above section 1, Hominy Creek  
at Candler, N.C.

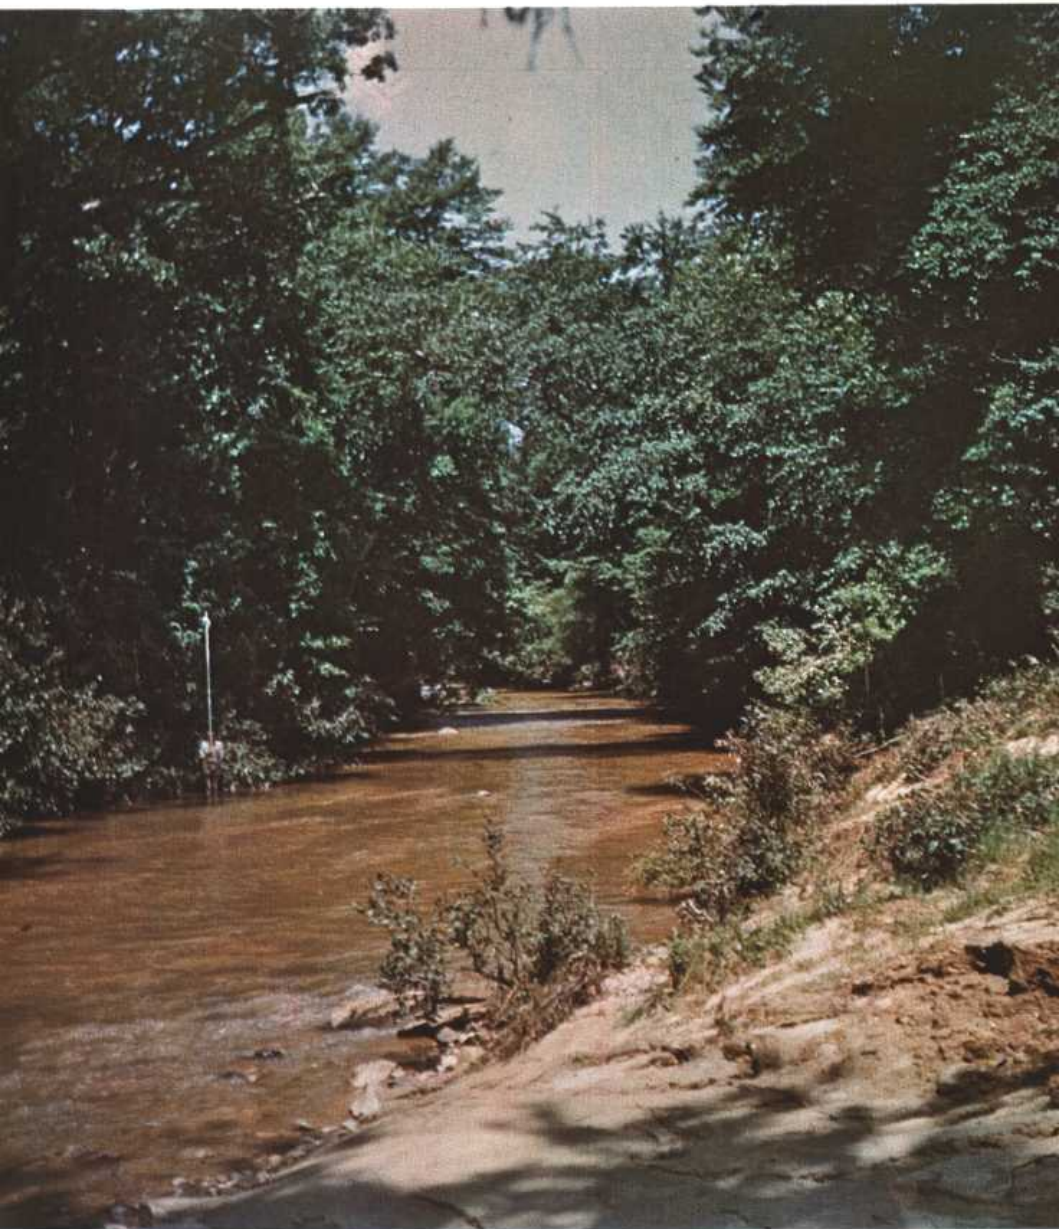
No. 432 upstream from left bank at section 3, Hominy Creek  
at Candler, N.C.

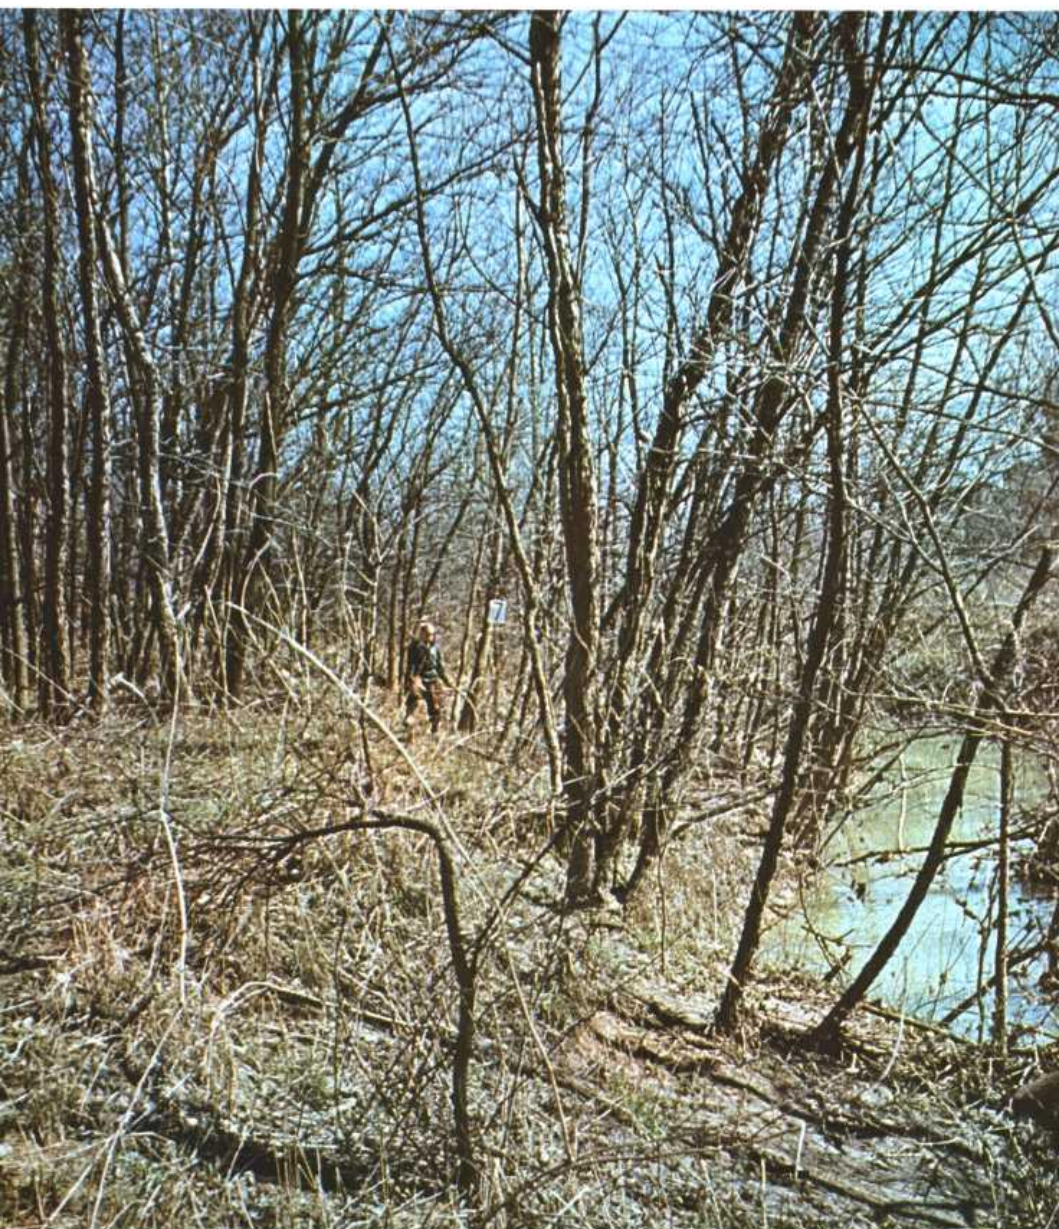
No. 453 upstream from right bank at section 7,  
Pond Creek near Louisville, Ky.

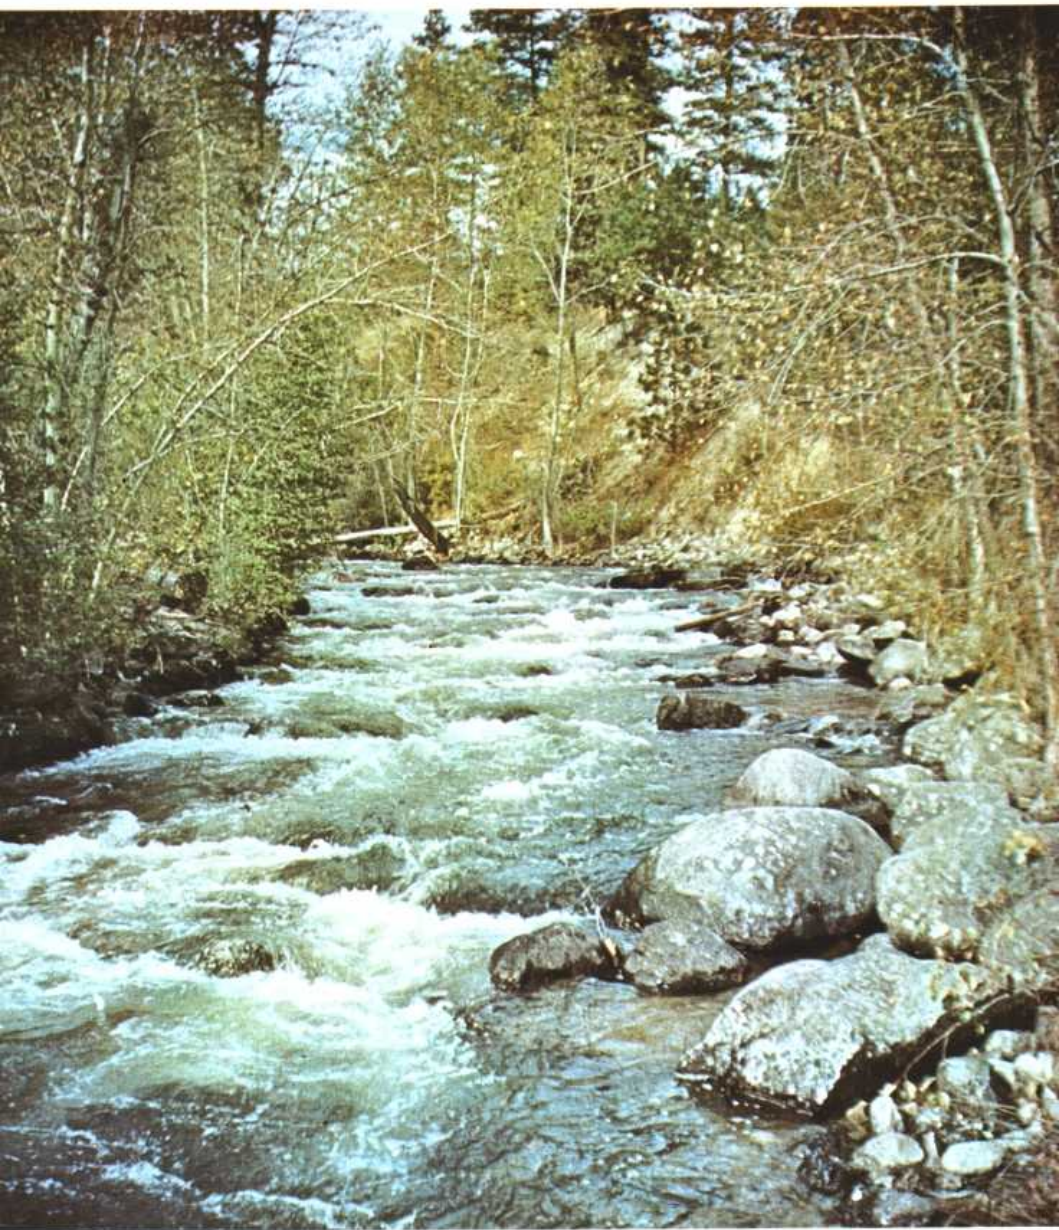
No. 133, upstream from below section 3,  
Rock Creek near Darby, Mont.
